CONFIDENTIAL ANALYSIS FOR THE MINISTER OF MUNICIPAL AFFAIRS

**NORTH AMERICAN MIDWAY ENTERTAINMENT
SCORPION RIDE ENGINEERING ASSESSMENT
DATE OF LOSS: JULY 16, 2010**

ANDERSON ASSOCIATES CONSULTING ENGINEERS INC.
APEGGA Permit Number P 2205

November 26, 2010

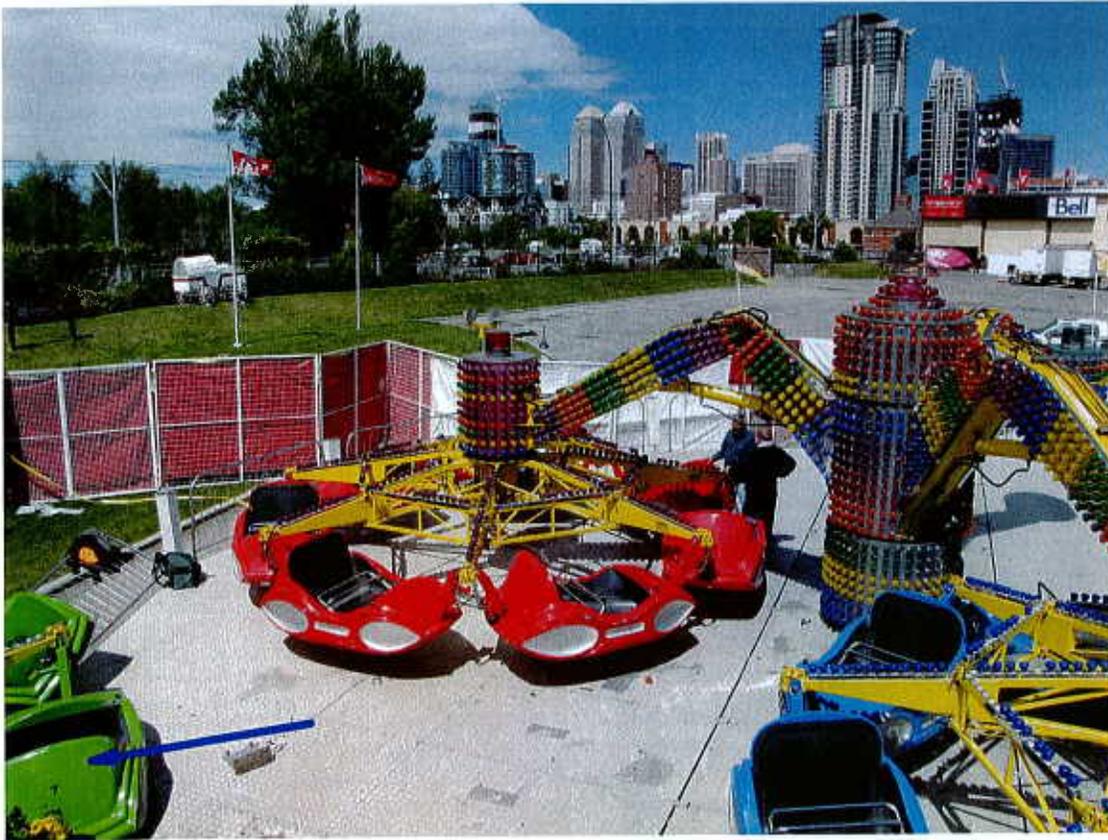
A1

An elevated view of the Scorpion ride on the left as seen from the control booth.

Note the detached green pods hanging on the edge of the platform in the lower left corner of the photograph (arrow).

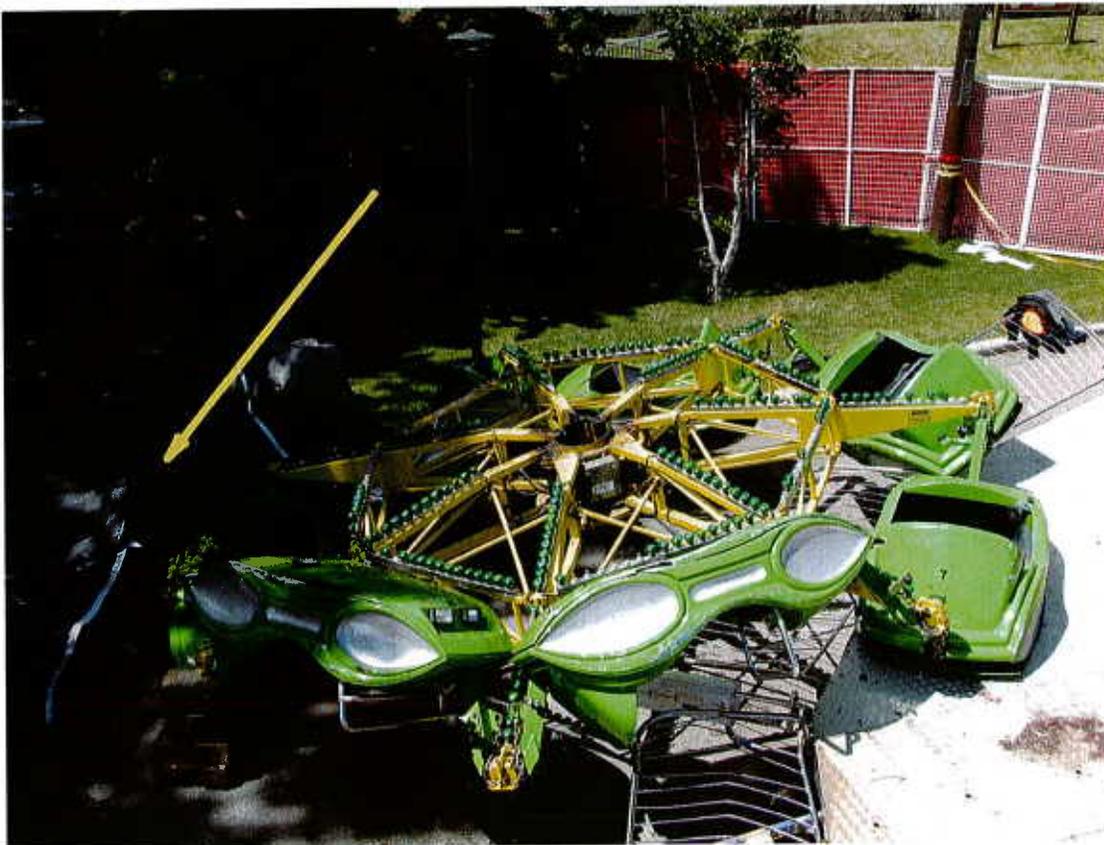
4.4.1 An overview of the green spinner sweep arm assembly is depicted in Photograph A2 after it came to rest following the incident. The fractured spinner hub is depicted in Photographs A11 and A12. The fracture occurred at a double fillet weld joining the spinner hub top flange to the spinner hub barrel.

A view of the green spinner sweep assembly that came apart at the top flange face weld.

Note the large rock to the left where it came to rest (arrow).

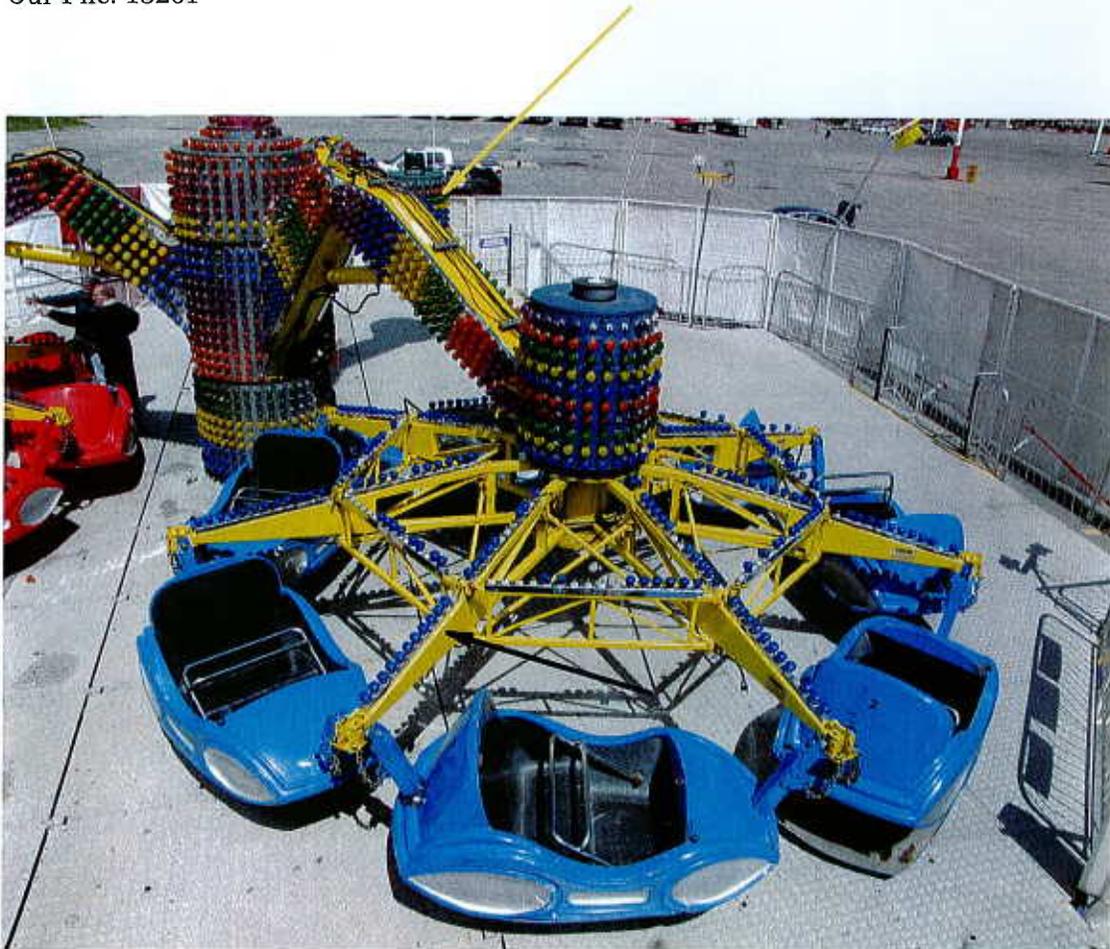
A3

An elevated view of the blue spinner sweep assembly attached to its respective hub. Note the fixed sweep arm of the assembly that has been identified by the black arrow.

Also note the yellow arrow pointing at the green spinner hub.

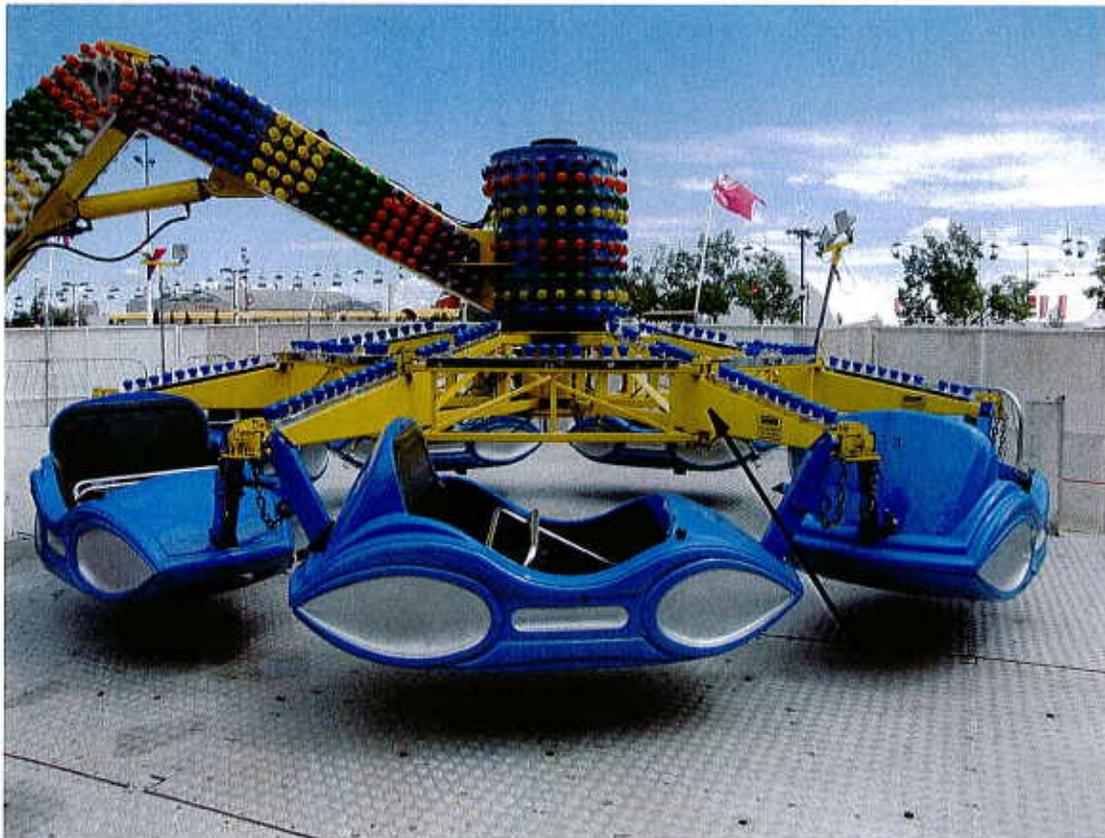
A4

A view of the blue spinner sweep assembly from deck level. The black arrow identifies the fixed sweep arm attached to the rear of pod 3.

A close inspection of the barrel to top flange weld in close proximity to this arm connection is shown in Photographs A13 through A16.

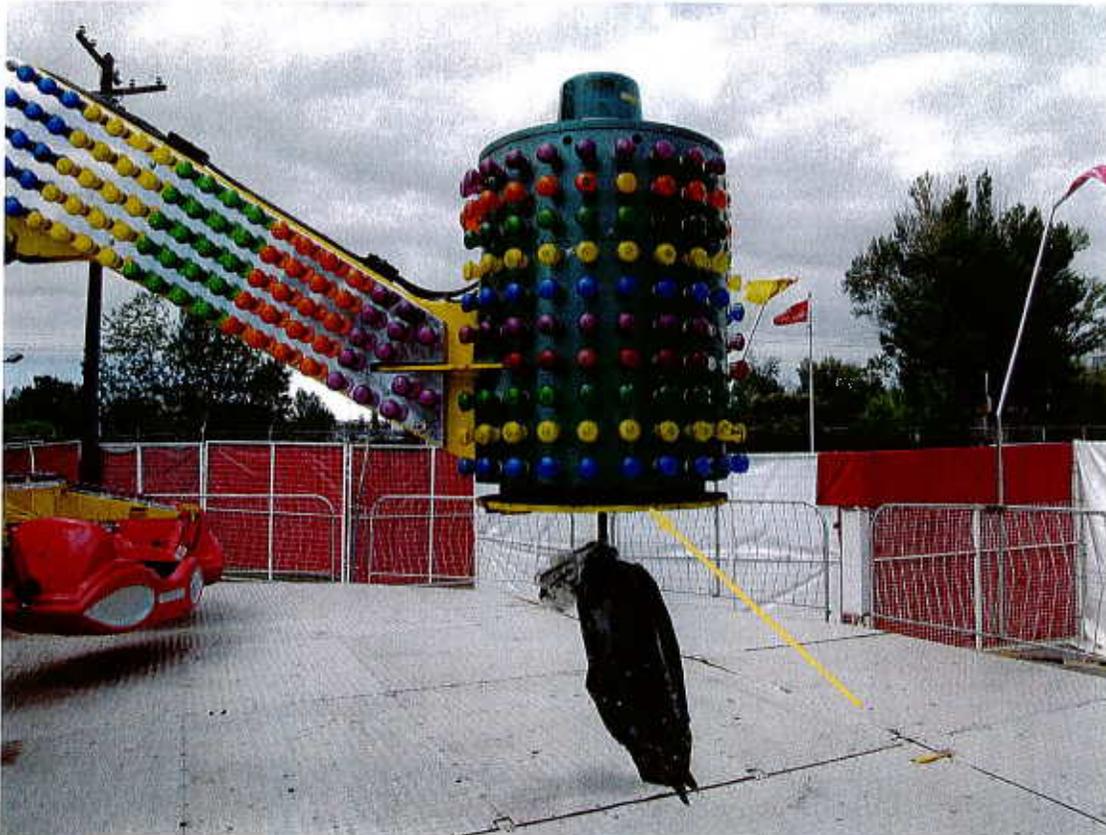
4.1.6 It was noted that the top plate of the green spinner hub assembly was still attached to its respective primary arm and that a weld failure had occurred (Photographs A6 to A12).

A view of the green hub on the end of the primary sweep arm.

Note the top flange from the detached spinner sweep assembly attached to the hub (arrow).

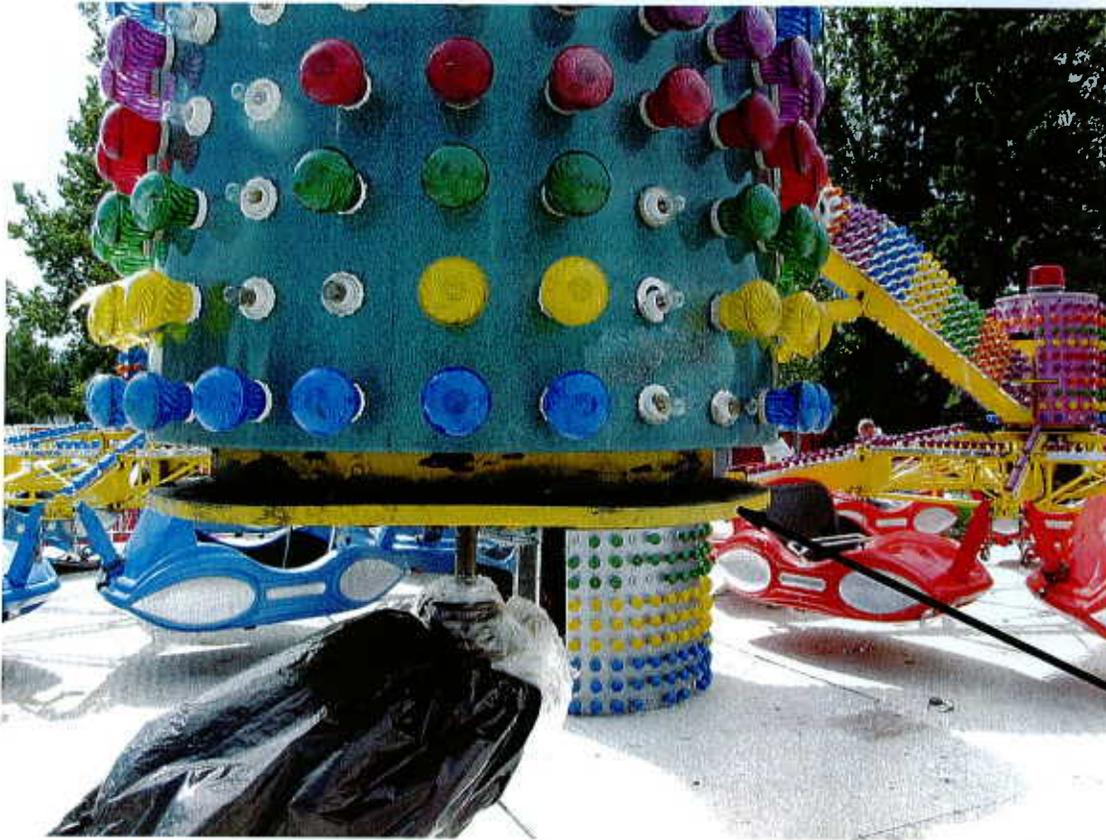
A7

A close view of the green spinner sweep assembly top flange plate attached to its respective hub (arrow).

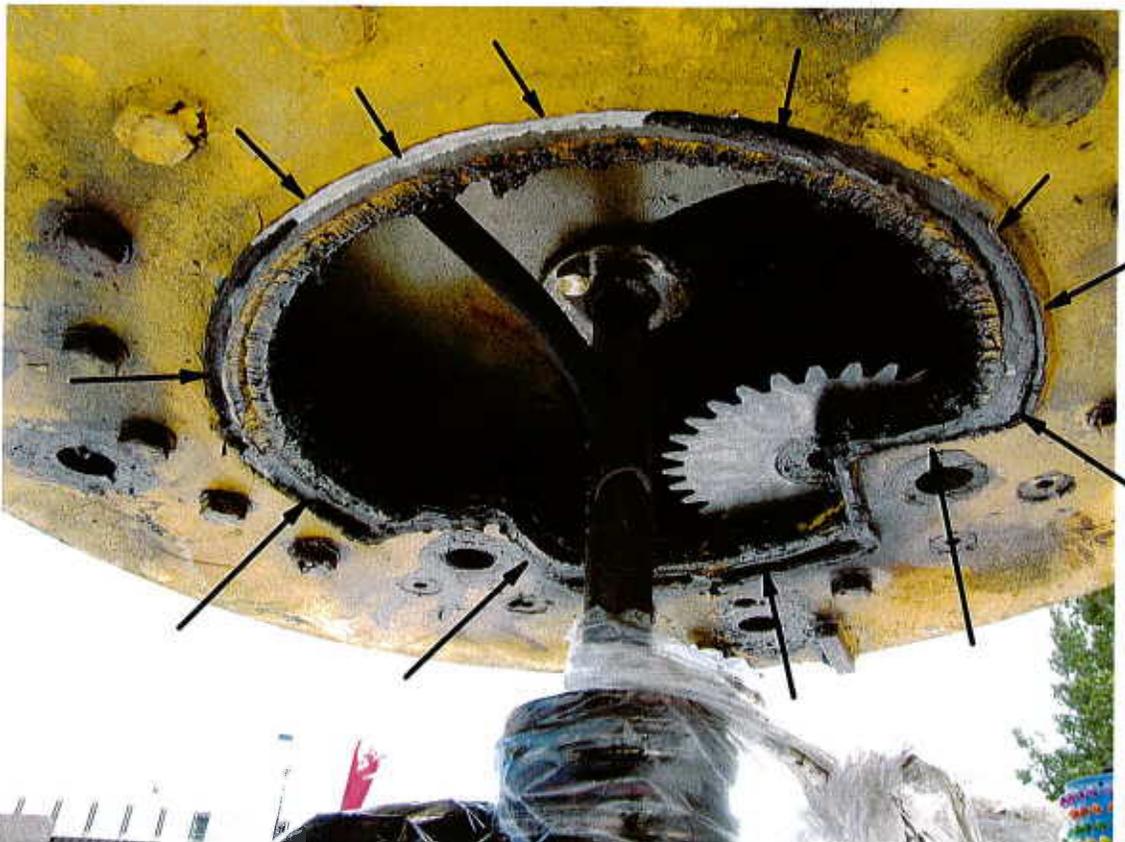
A8

A view showing the weld fracture surface on the top flange plate (arrows).

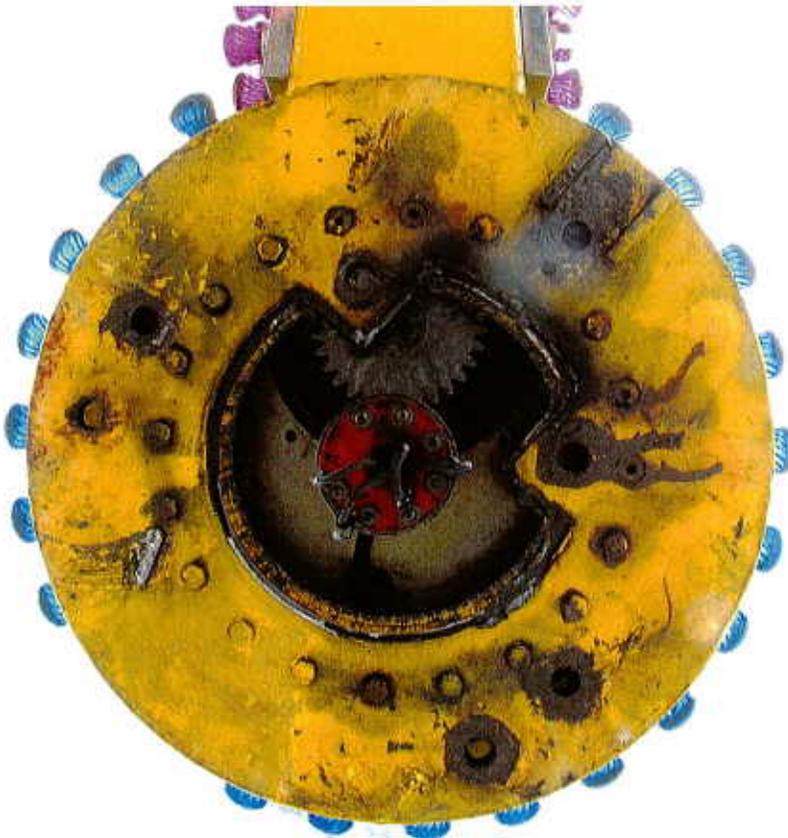
A10

A view showing the entire face of the top flange and weld fracture surface.

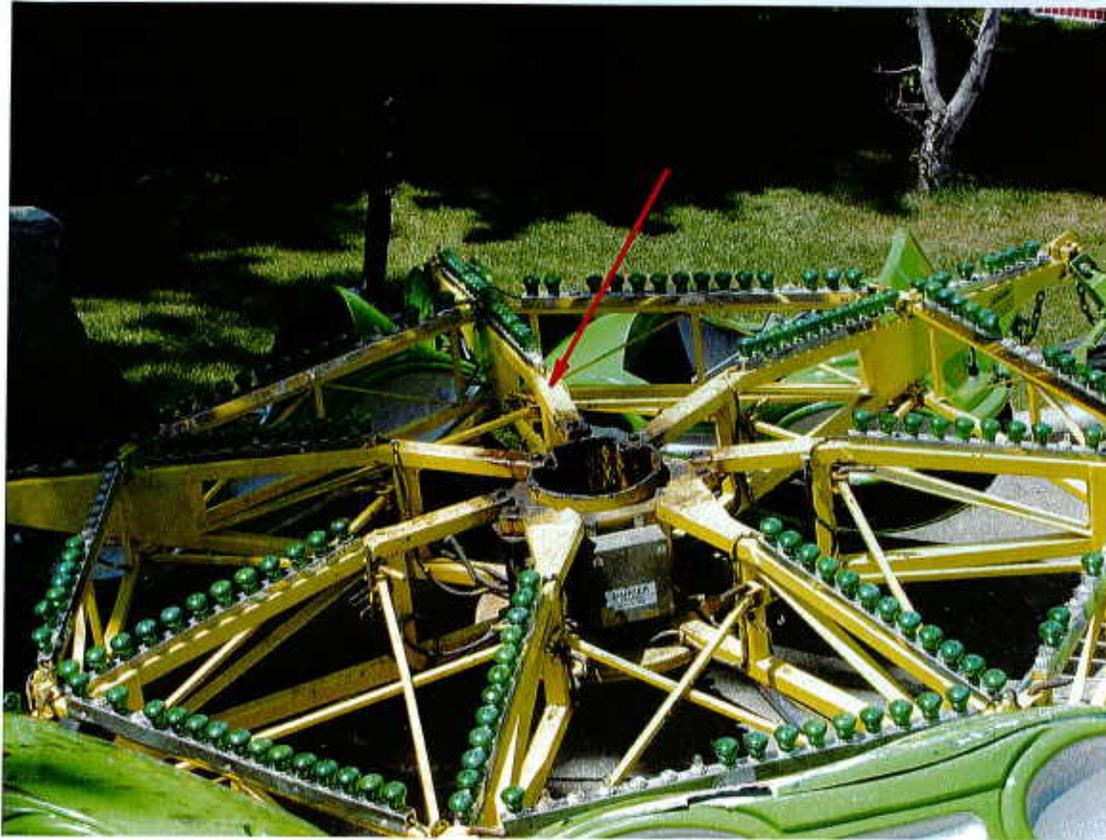
A11

A closer view of the green spinner sweep assembly that came apart at the top flange face weld.

Note the red arrow pointing to the sweep arm that was once fixed by the missing top flange.

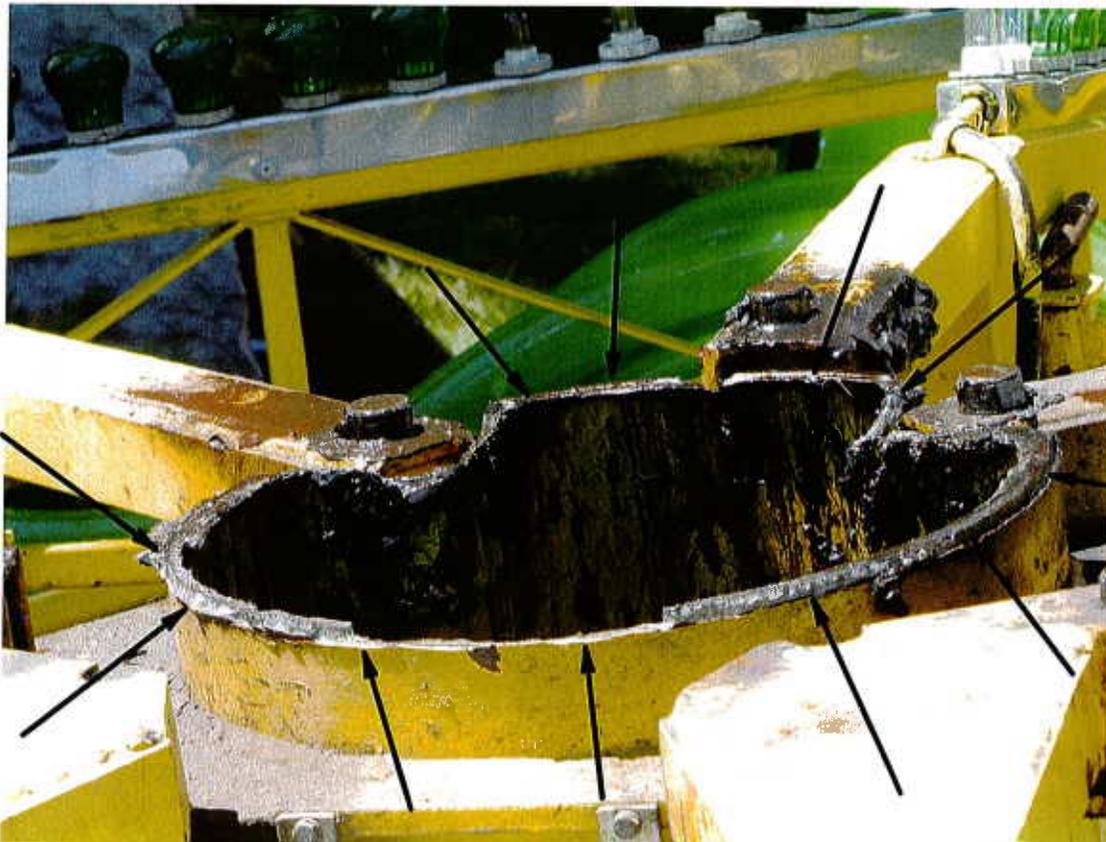
A12

A closer view of the failed weld section (arrows).

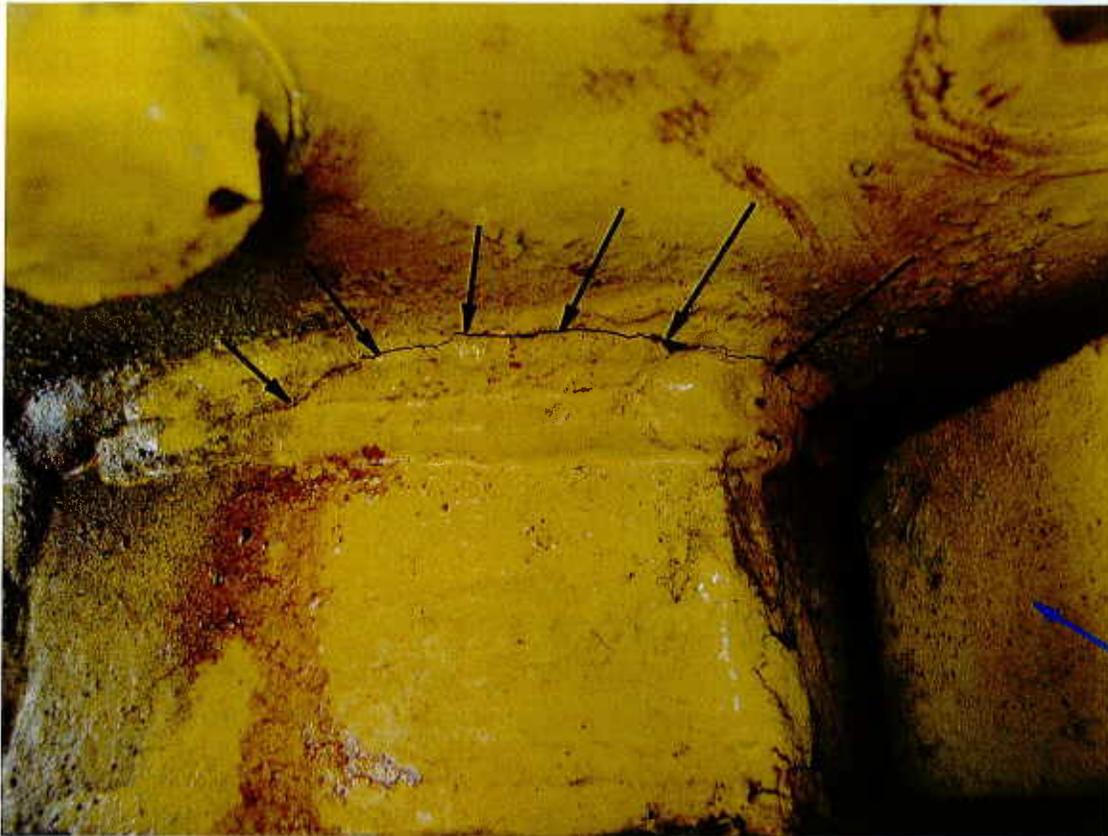
A13

4.1.7 A visual inspection of the blue spinner sweep arm assembly revealed a significant crack in the weld located between the top flange and barrel of the spinner hub assembly in close proximity to the location where the fixed secondary sweep arm was pinned to the top flange plate. It was also noted that a weld repair was evident on the opposite symmetrical side of the fixed sweep arm (Photographs A13, A14 and A16).

A view of the barrel to top flange weld on the blue spinner sweep assembly at a location just right of the fixed sweep arm. The blue arrow identifies the adjacent sweep arm to the right of the fixed sweep arm.

Note the visible crack that can be seen in this view (black arrows).

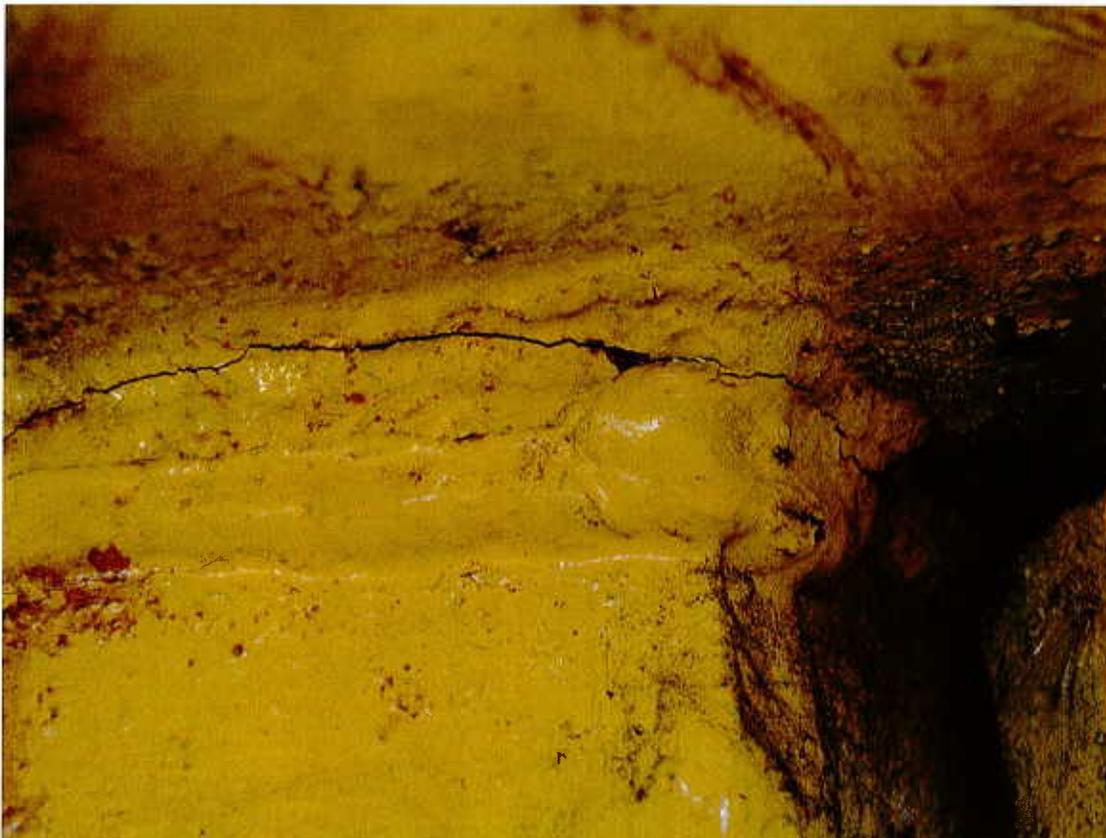
A14

A closer view of the crack referenced in the photo above. This corner location is a definite stress concentration riser.

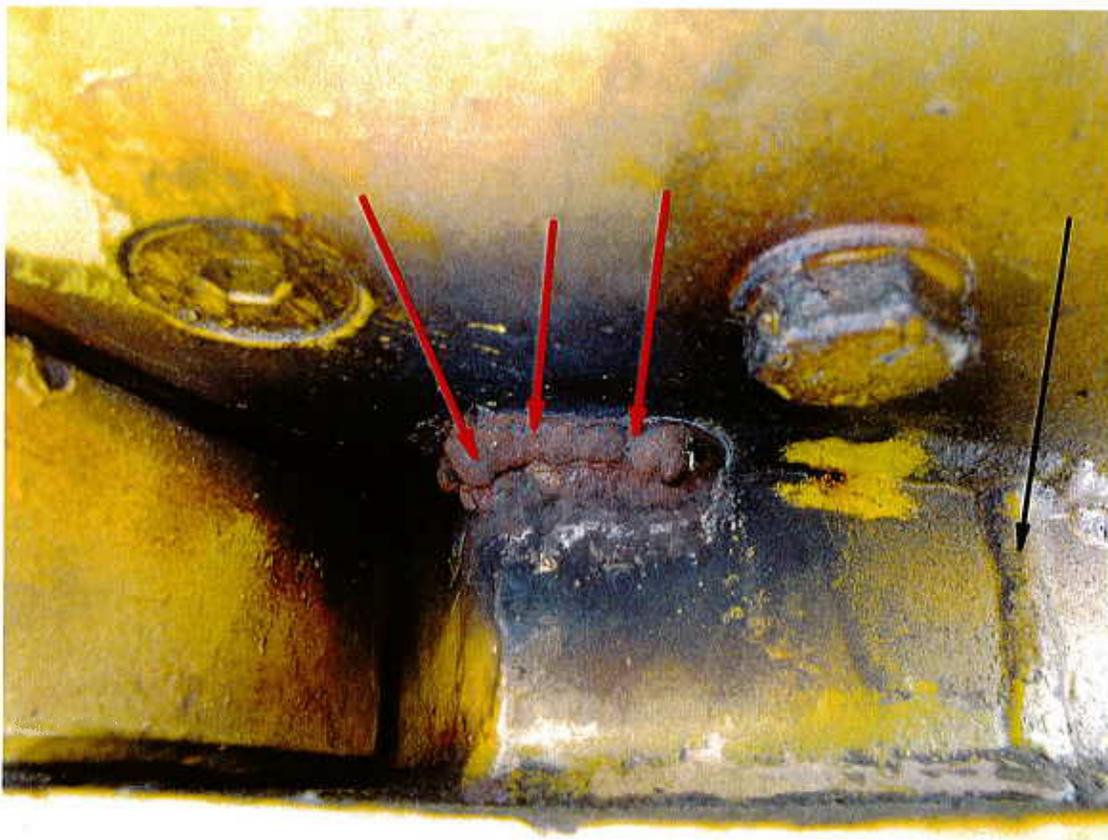
A16

A view of the barrel to top flange weld on the blue spinner sweep assembly at a location just left of the fixed sweep arm.

Note the weld repair that was attempted at this high stress concentration location (red arrows).

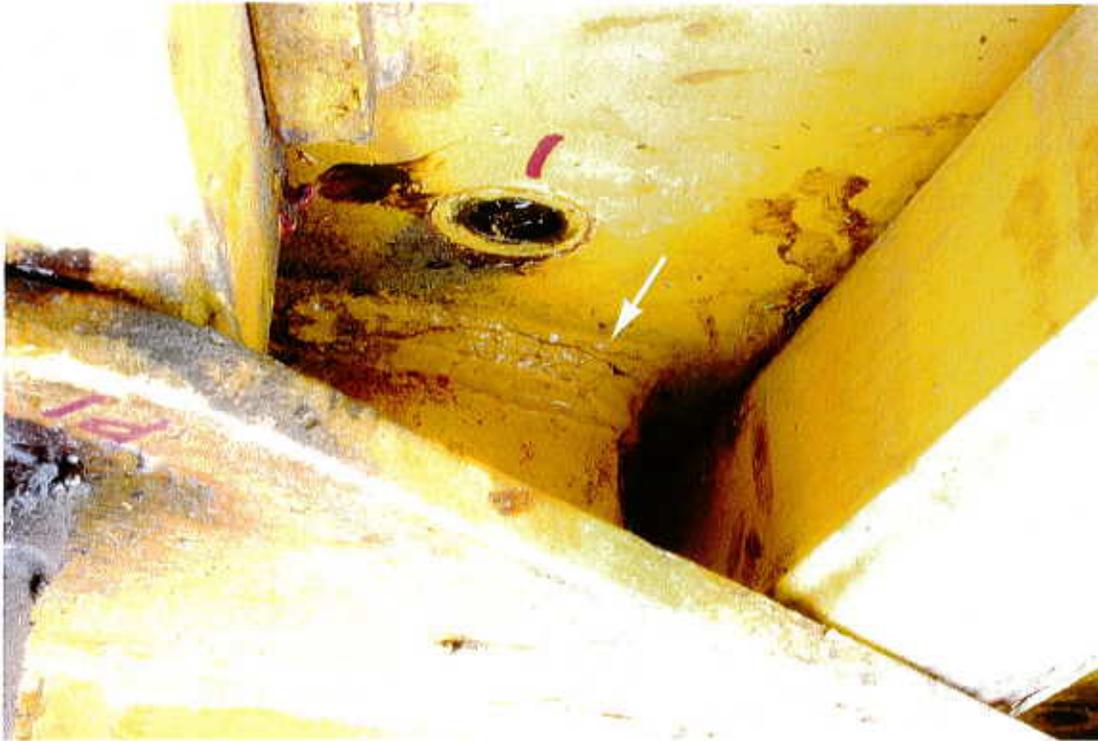
4.3.2 Photograph B3 is a close-up view depicting what is a cracked weld at the top-flange-to-barrel weld near location 1 (locations are presented in Photographs C1 and C2). Photograph B4 is a close-up view showing a weld repair between locations 18 and 19 on the blue spinner hub top-flange-to-barrel weld. Photograph B3 can be compared with Photographs A13 and A14; Photograph B4 can be compared with Photograph A16.

View showing the blue spinner hub top flange to barrel outer weld near location 1.

Note a crack is visible in the weld (white arrow).sp

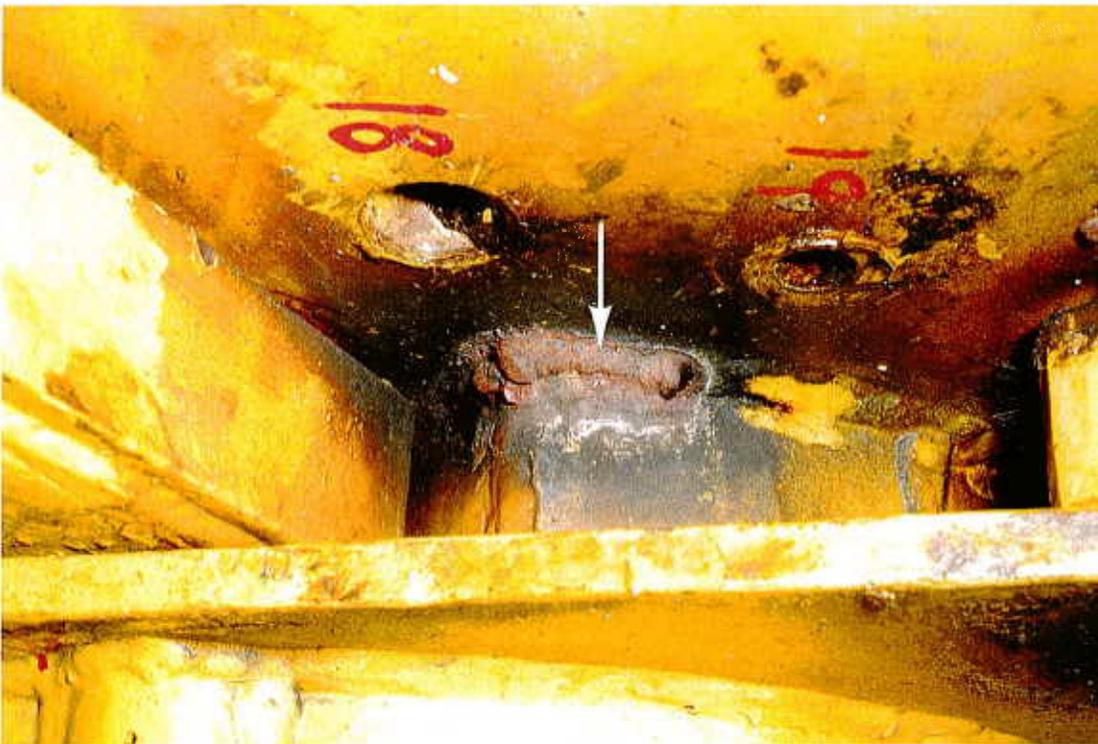
B4

View showing the blue spinner hub top flange to barrel outer weld near locations 18 and 19.

Note a weld repair is visible (arrow).

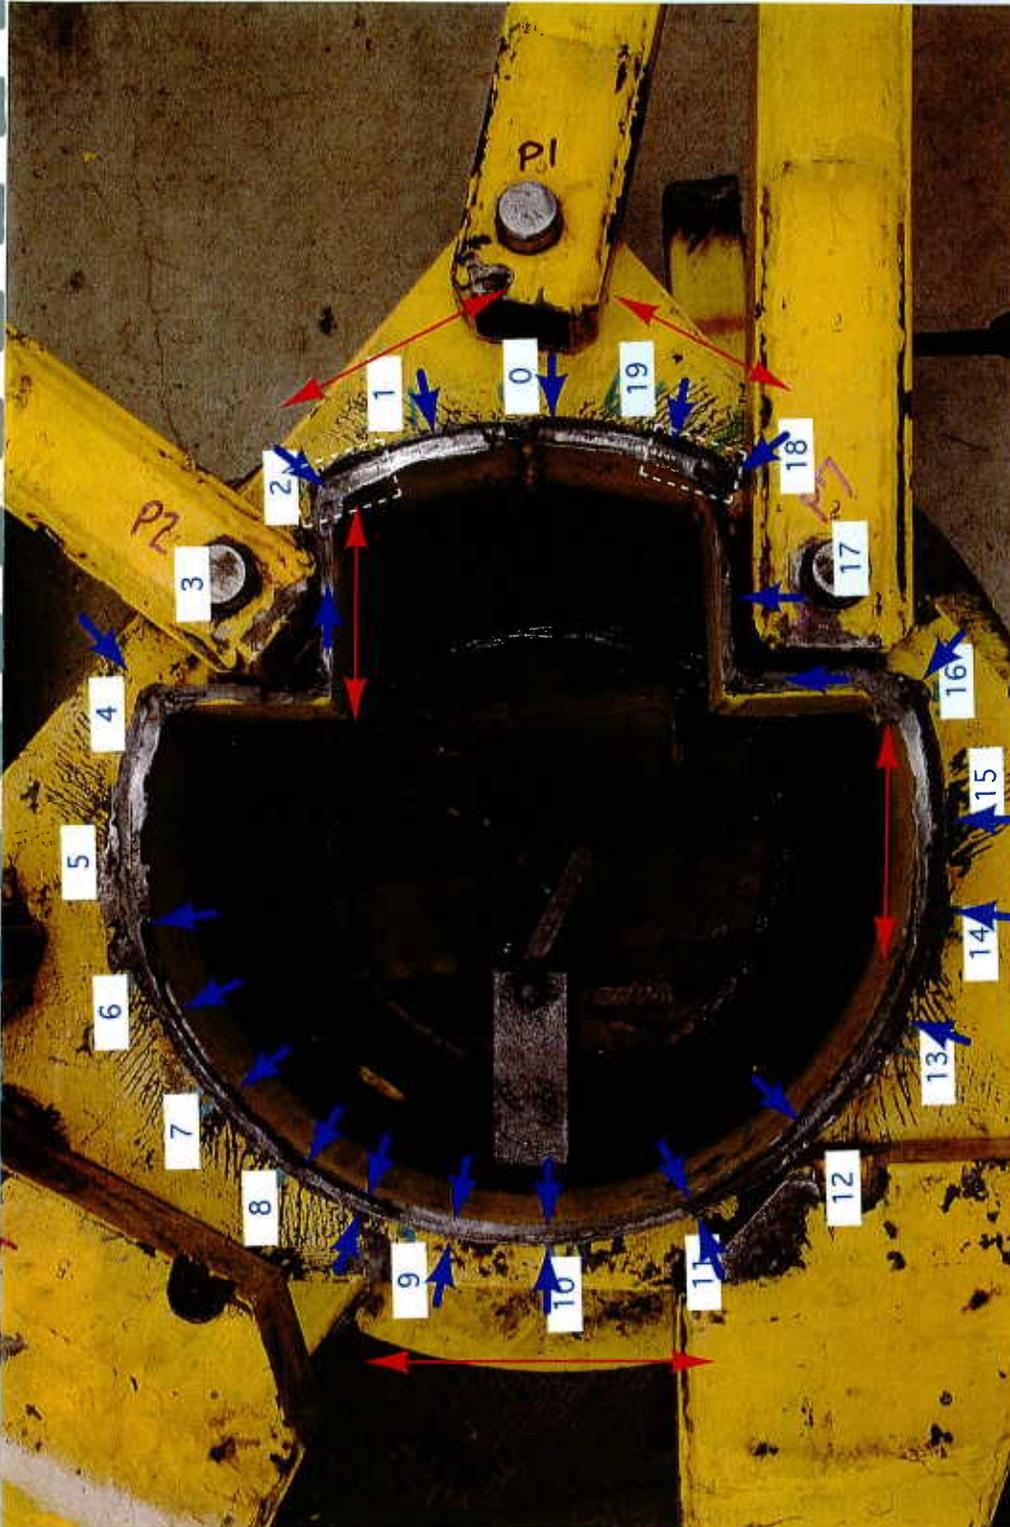
4.5.1 The green spinner barrel fracture is shown in Photograph C1 and the mating flange fracture is shown in Photograph C2. To provide a reference, the flange and barrel were numbered 0 through 19.

4.5.2 The approximate crack propagation paths, shown on both views, depict a pattern of one way bending fatigue (fatigue crack propagation from one direction) in some areas, locations 1 through 16, and two-way bending fatigue in others, locations 9 through 11. Extensive post-fracture

mechanical damage was evident in locations 0, 1, 2, 3, 4, 5, 15, 16, 17, 18 and 19.

View showing the green spinner hub barrel fracture.

The blue arrows indicate the direction of crack propagation.

The fracture surface was mechanically damaged in zones 15, 4, 3, 2, 1, 0, 19, 18, 17, 16.

The weld repair locations are indicated by the white dashed boxes.

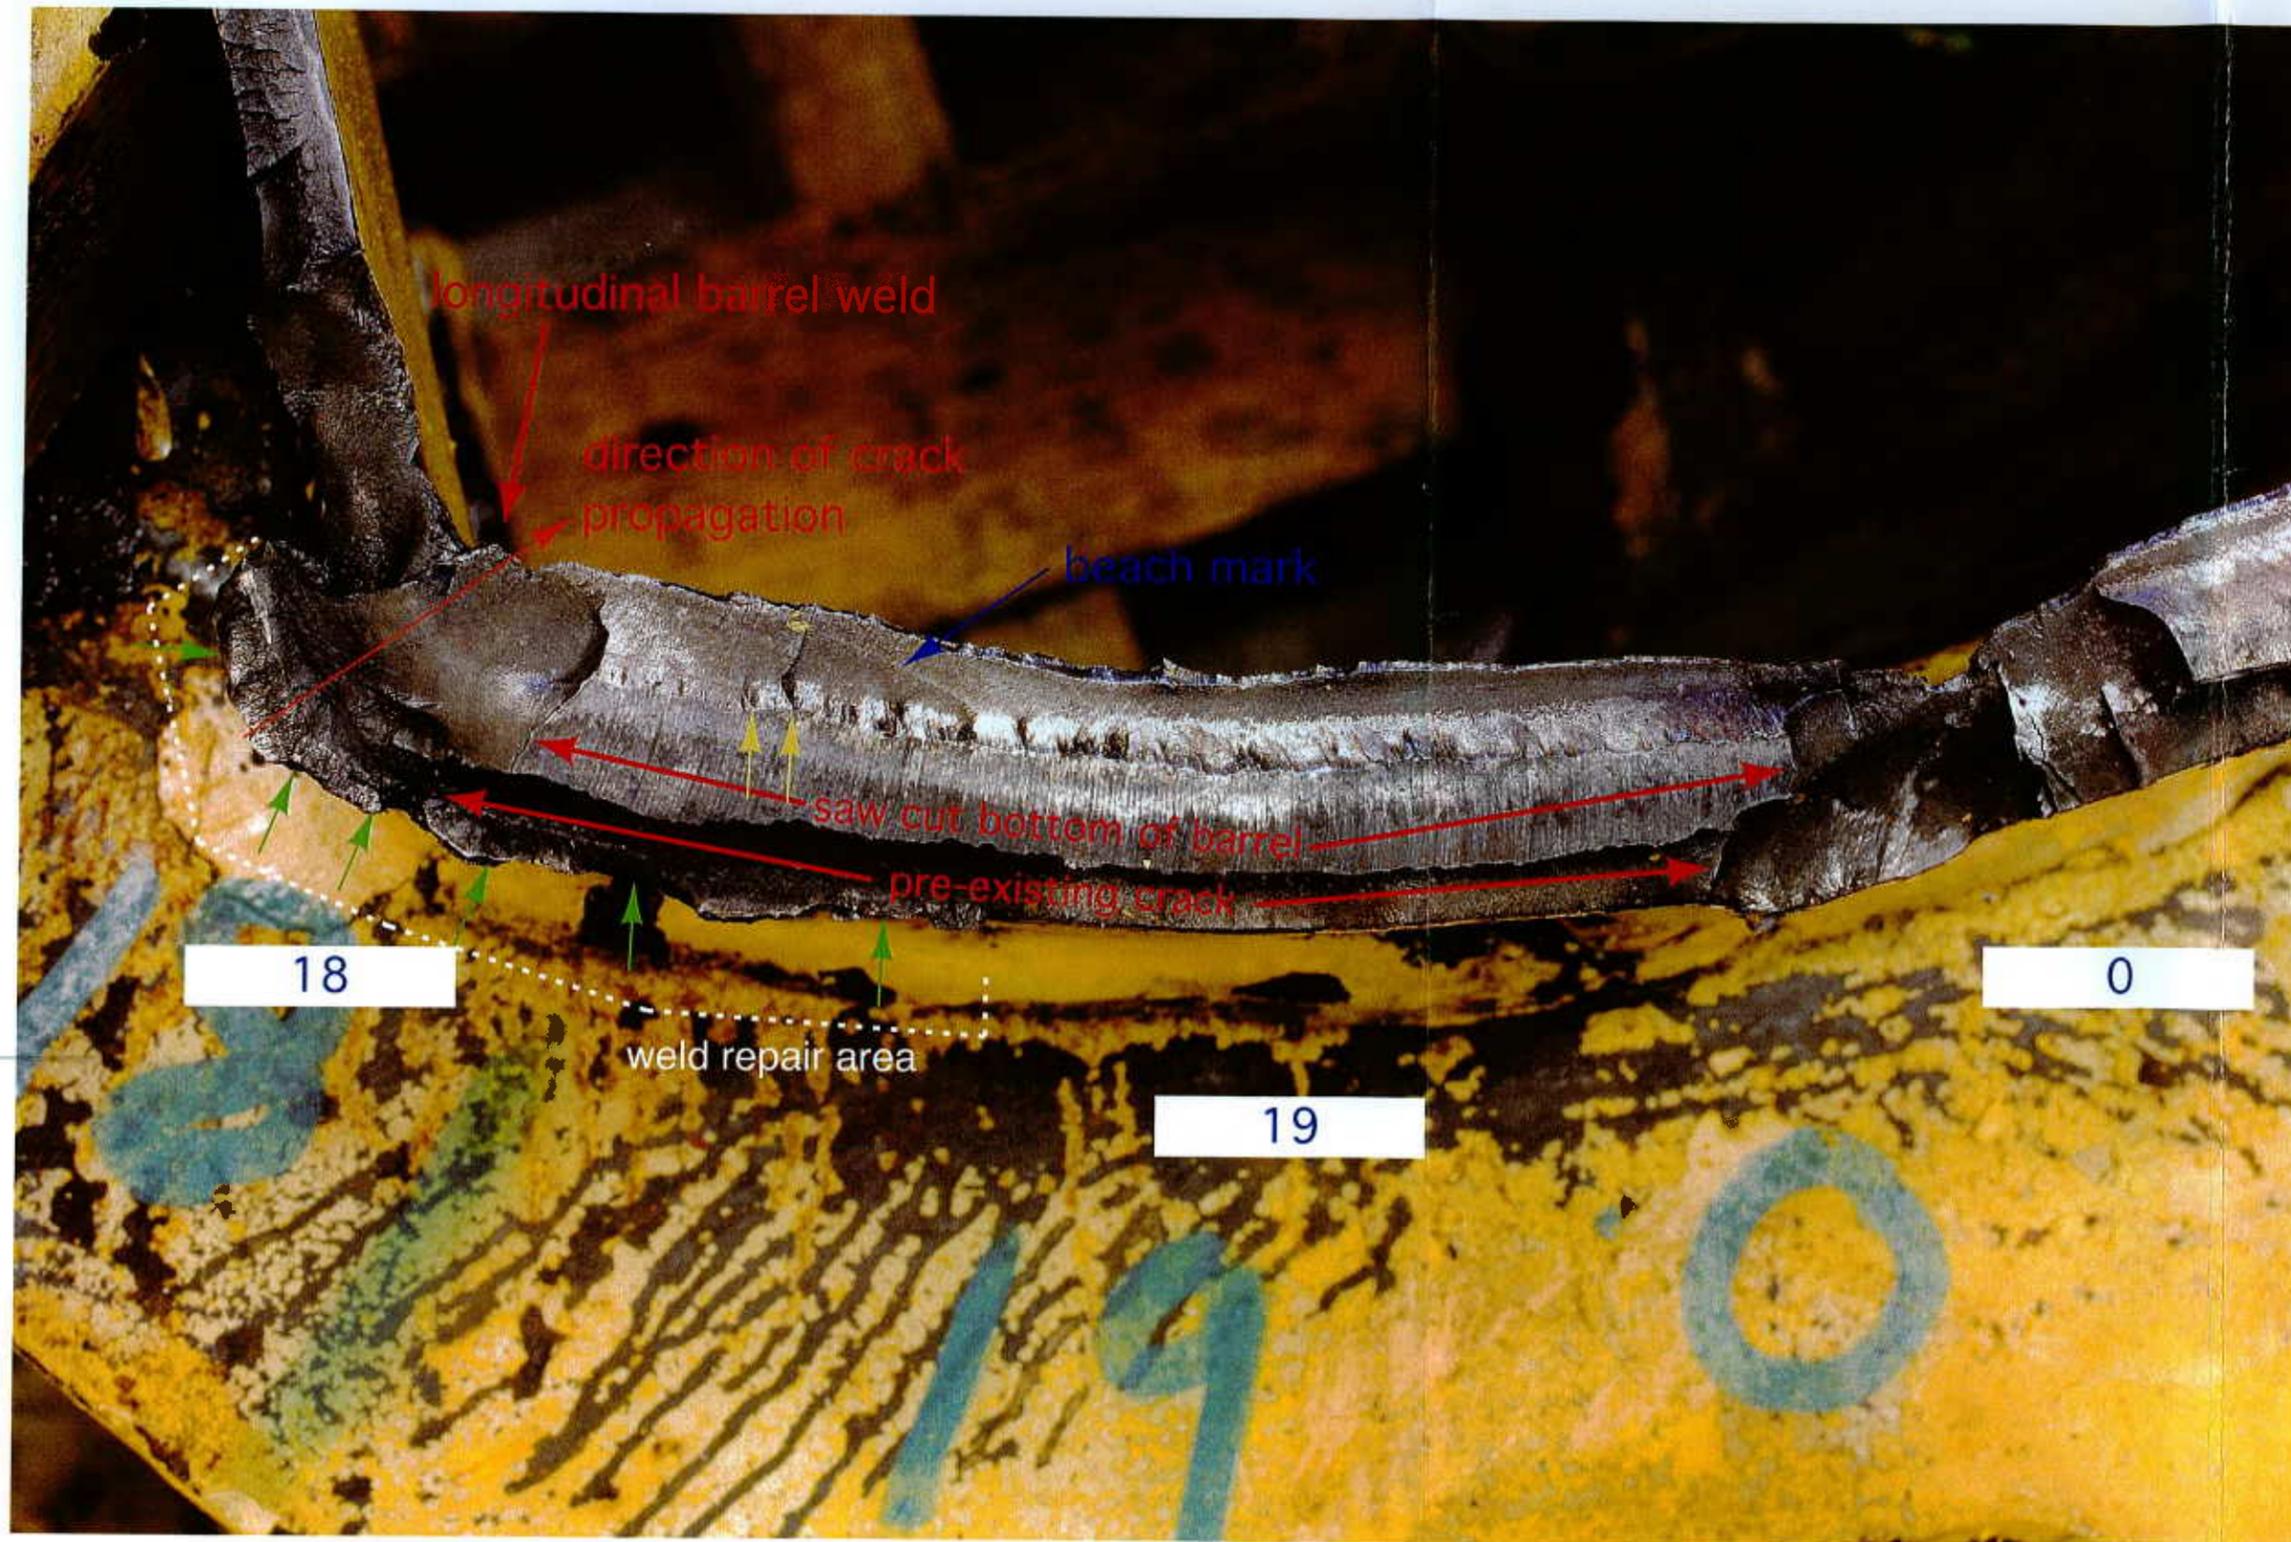
- 4.5.3 A close-up view the barrel fracture in locations 18, 19, and 0 is depicted in Photograph C3. This view depicts the barrel side fracture at one of the longitudinal or vertical welds. This area also represents one of the two weld repair locations. In this general area, cracking initiated at the outer diameter and propagated toward the inner diameter. In most locations, the crack propagation mode is cyclical; that is, in the bending fatigue fracture mode.

- 4.5.4 A weld repair is clearly evident near location 18. The intent of this weld repair was to fix a pre-existing fatigue crack. The weld repair itself is also cracked. The pre-existing fatigue crack is heat tinted from the effects of the repair weld; therefore, this crack was present at the time of the weld repair and was not effectively repaired. Further along toward location 19, this same fatigue crack (labeled in Photograph C3 as pre-existing) ultimately propagated toward the barrel's outer wall where it ended then restarted at the original manufacturer's weld/inner barrel interface and then became a through-wall crack. The fracture mode in the manufacturer's weld is primarily in the bending fatigue fracture mode.

Close-up view of the barrel fracture in zones 18, 19, and 0. This view depicts the barrel side fracture at one of the longitudinal welds. This area also represents one of the weld repair locations (white dashed line). Although difficult to see in this view, cracking initiates around area 18 in this weld repair and propagates toward the barrel's inner diameter wall (green arrows). Near the longitudinal weld this crack propagates through what appears to be the corner where three welds intersect and continues to the inner diameter of the barrel (orange arrow).

Moving toward the right, away from the weld repair area or circumferentially along the outer diameter, a crack originating at the fusion line of the original manufacturing weld propagates radially toward the barrel material. This crack is visible almost all the way to location 0. This crack clearly existed prior to the weld repair crack as it is visible in the original weld behind the area of weld repair (pre-existing crack area).

Note the post fracture mechanical damage appearing as shiny areas on this fracture surface.
