CONFIDENTIAL ANALYSIS FOR THE MINISTER OF MUNICIPAL AFFAIRS

**NORTH AMERICAN MIDWAY ENTERTAINMENT
SCORPION RIDE ENGINEERING ASSESSMENT
DATE OF LOSS: JULY 16, 2010**

ANDERSON ASSOCIATES CONSULTING ENGINEERS INC.
APEGGA Permit Number P 2205

November 26, 2010

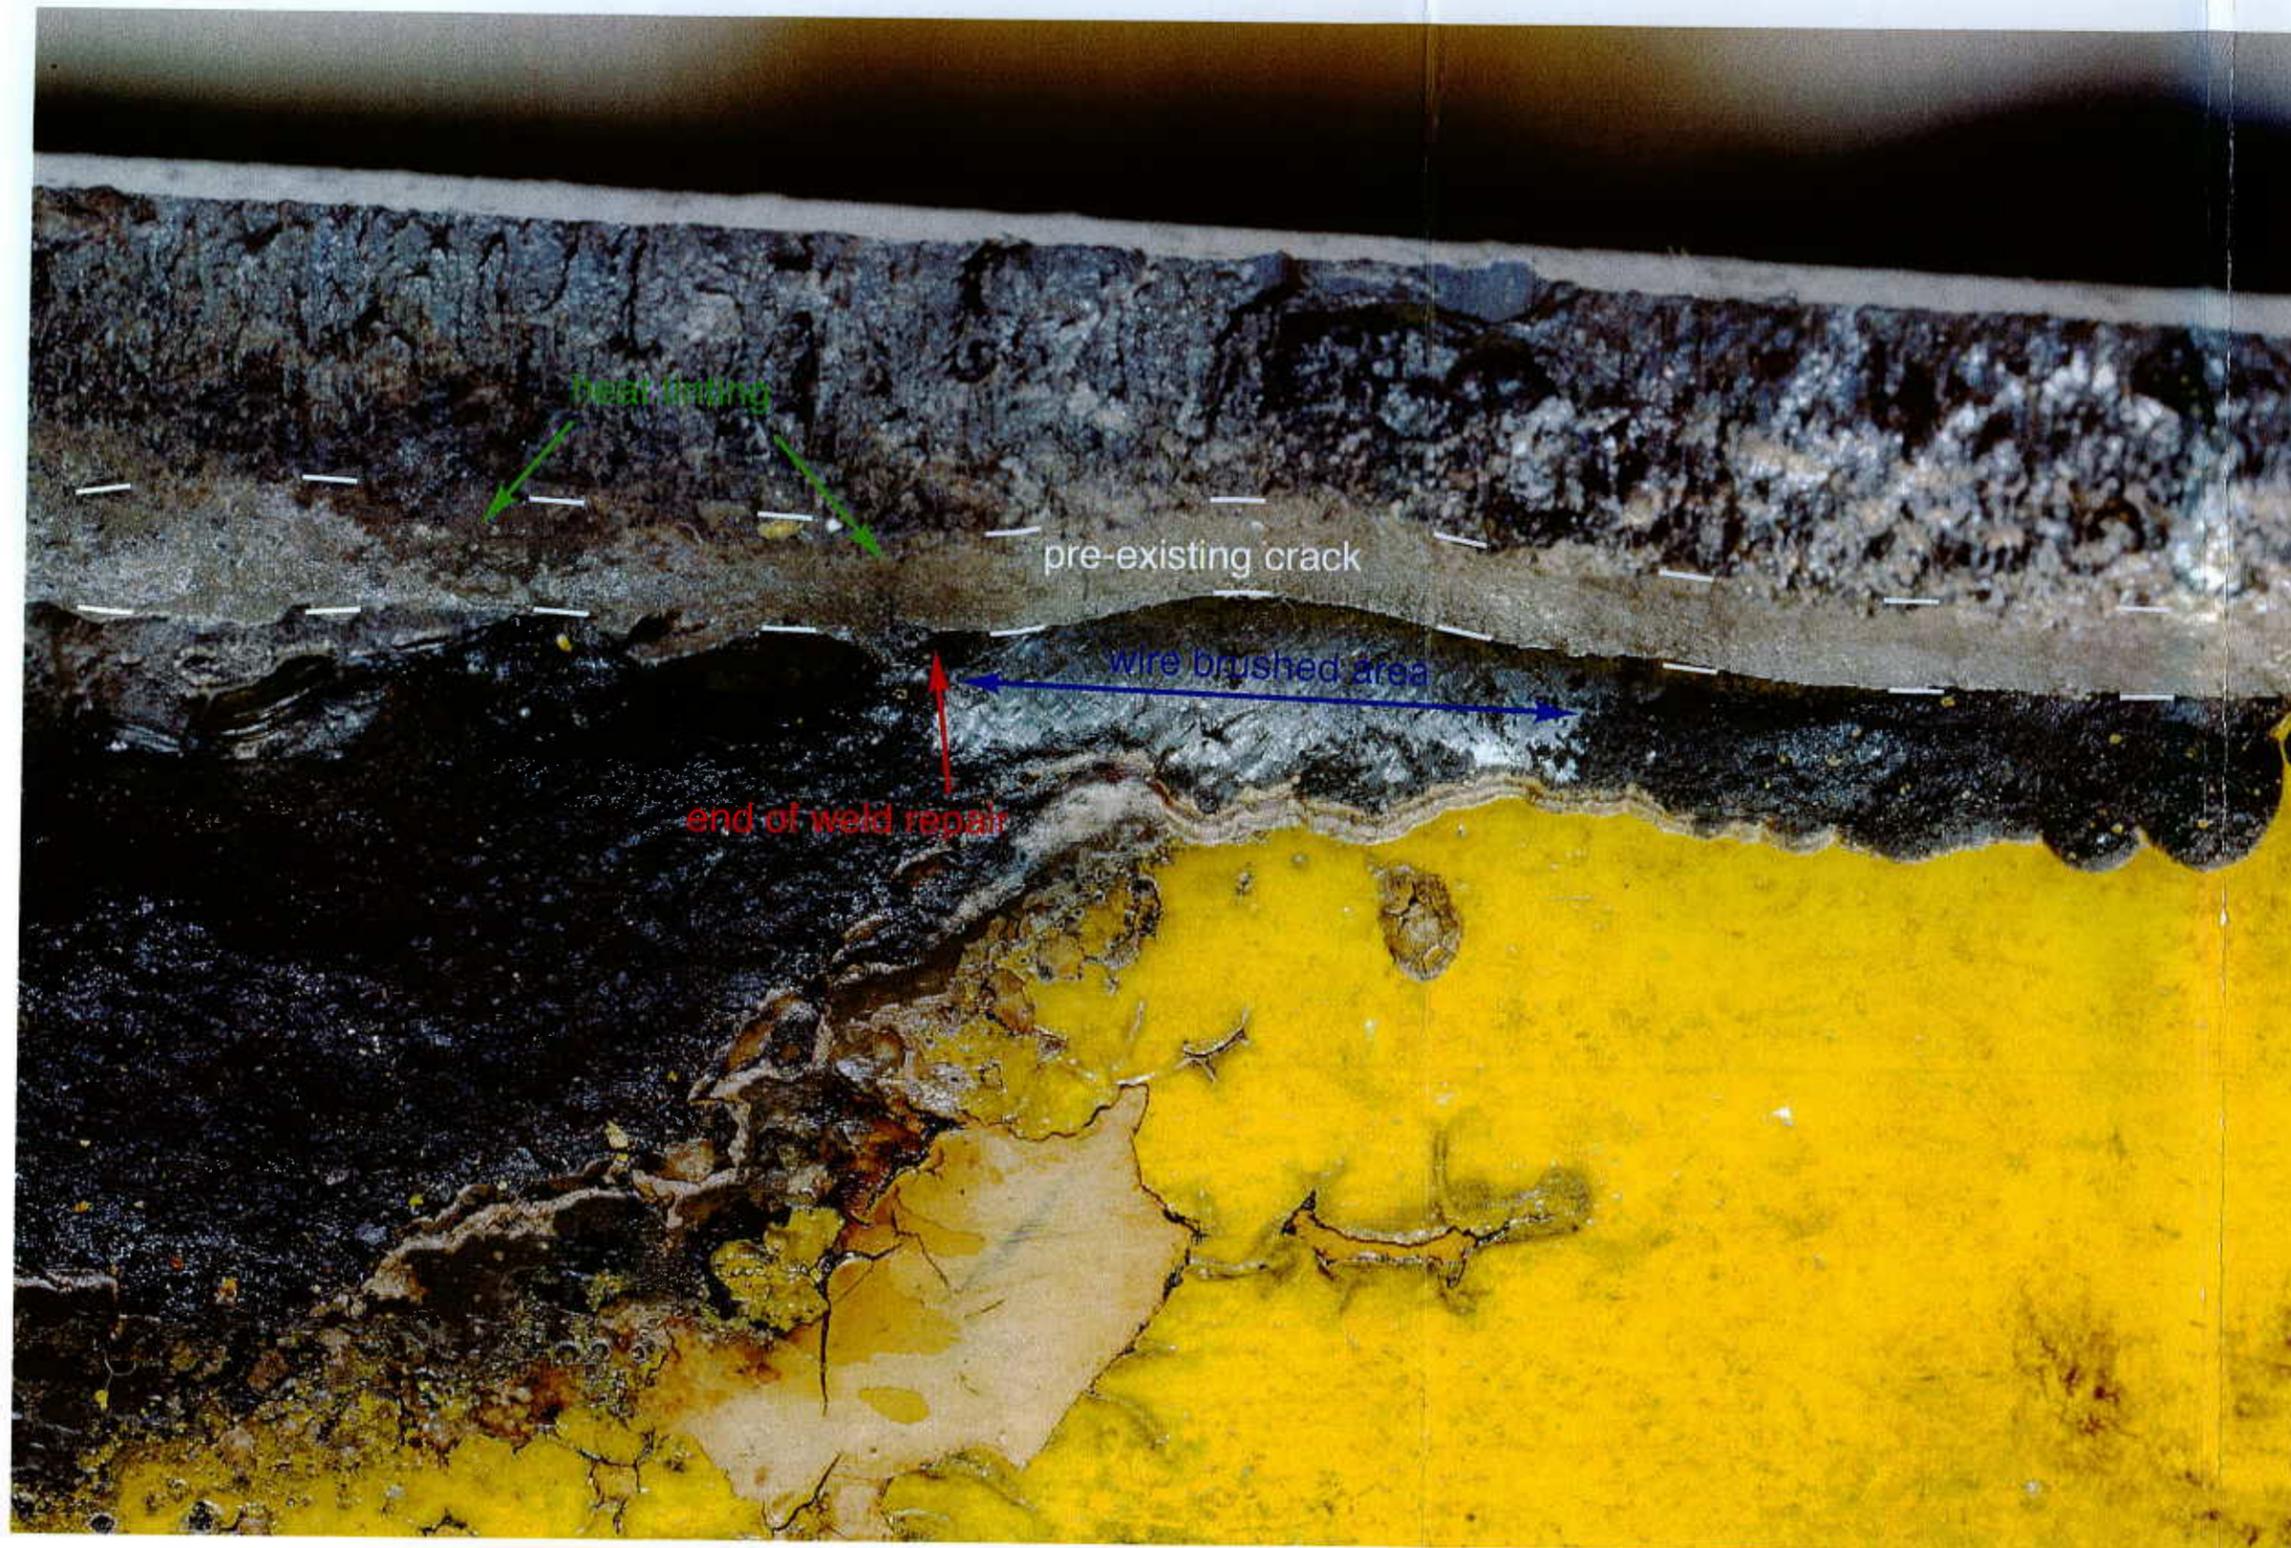
- 4.5.5 A close-up view of location 19 is shown in Photographs C4 and C5. These views are close ups of the weld repair/original manufacturer's weld interface. These views depict high temperature oxidization or heat tinting on the crack fracture

surface. This heat tinting gives us some indication that a fatigue crack (marked in white as pre-existing crack) was present in the manufacturer's weld and that a weld repair was attempted over top of the crack. There is no indication that this fatigue crack was gouged out completely before welding. The heat tinting on this pre-existing crack surface also indicates that the crack was present and extending beyond the weld repair.

Oblique view of the barrel fracture between zones 18 and 19. This view depicts the end of the weld repair (red arrow) and also shows an area where it appears that the side of the barrel has been wire brushed in preparation for welding but was not welded (blue arrow).

Heat tinting was clearly visible (green arrows) indicating that the crack existed prior to the weld repair (white dashed lines).

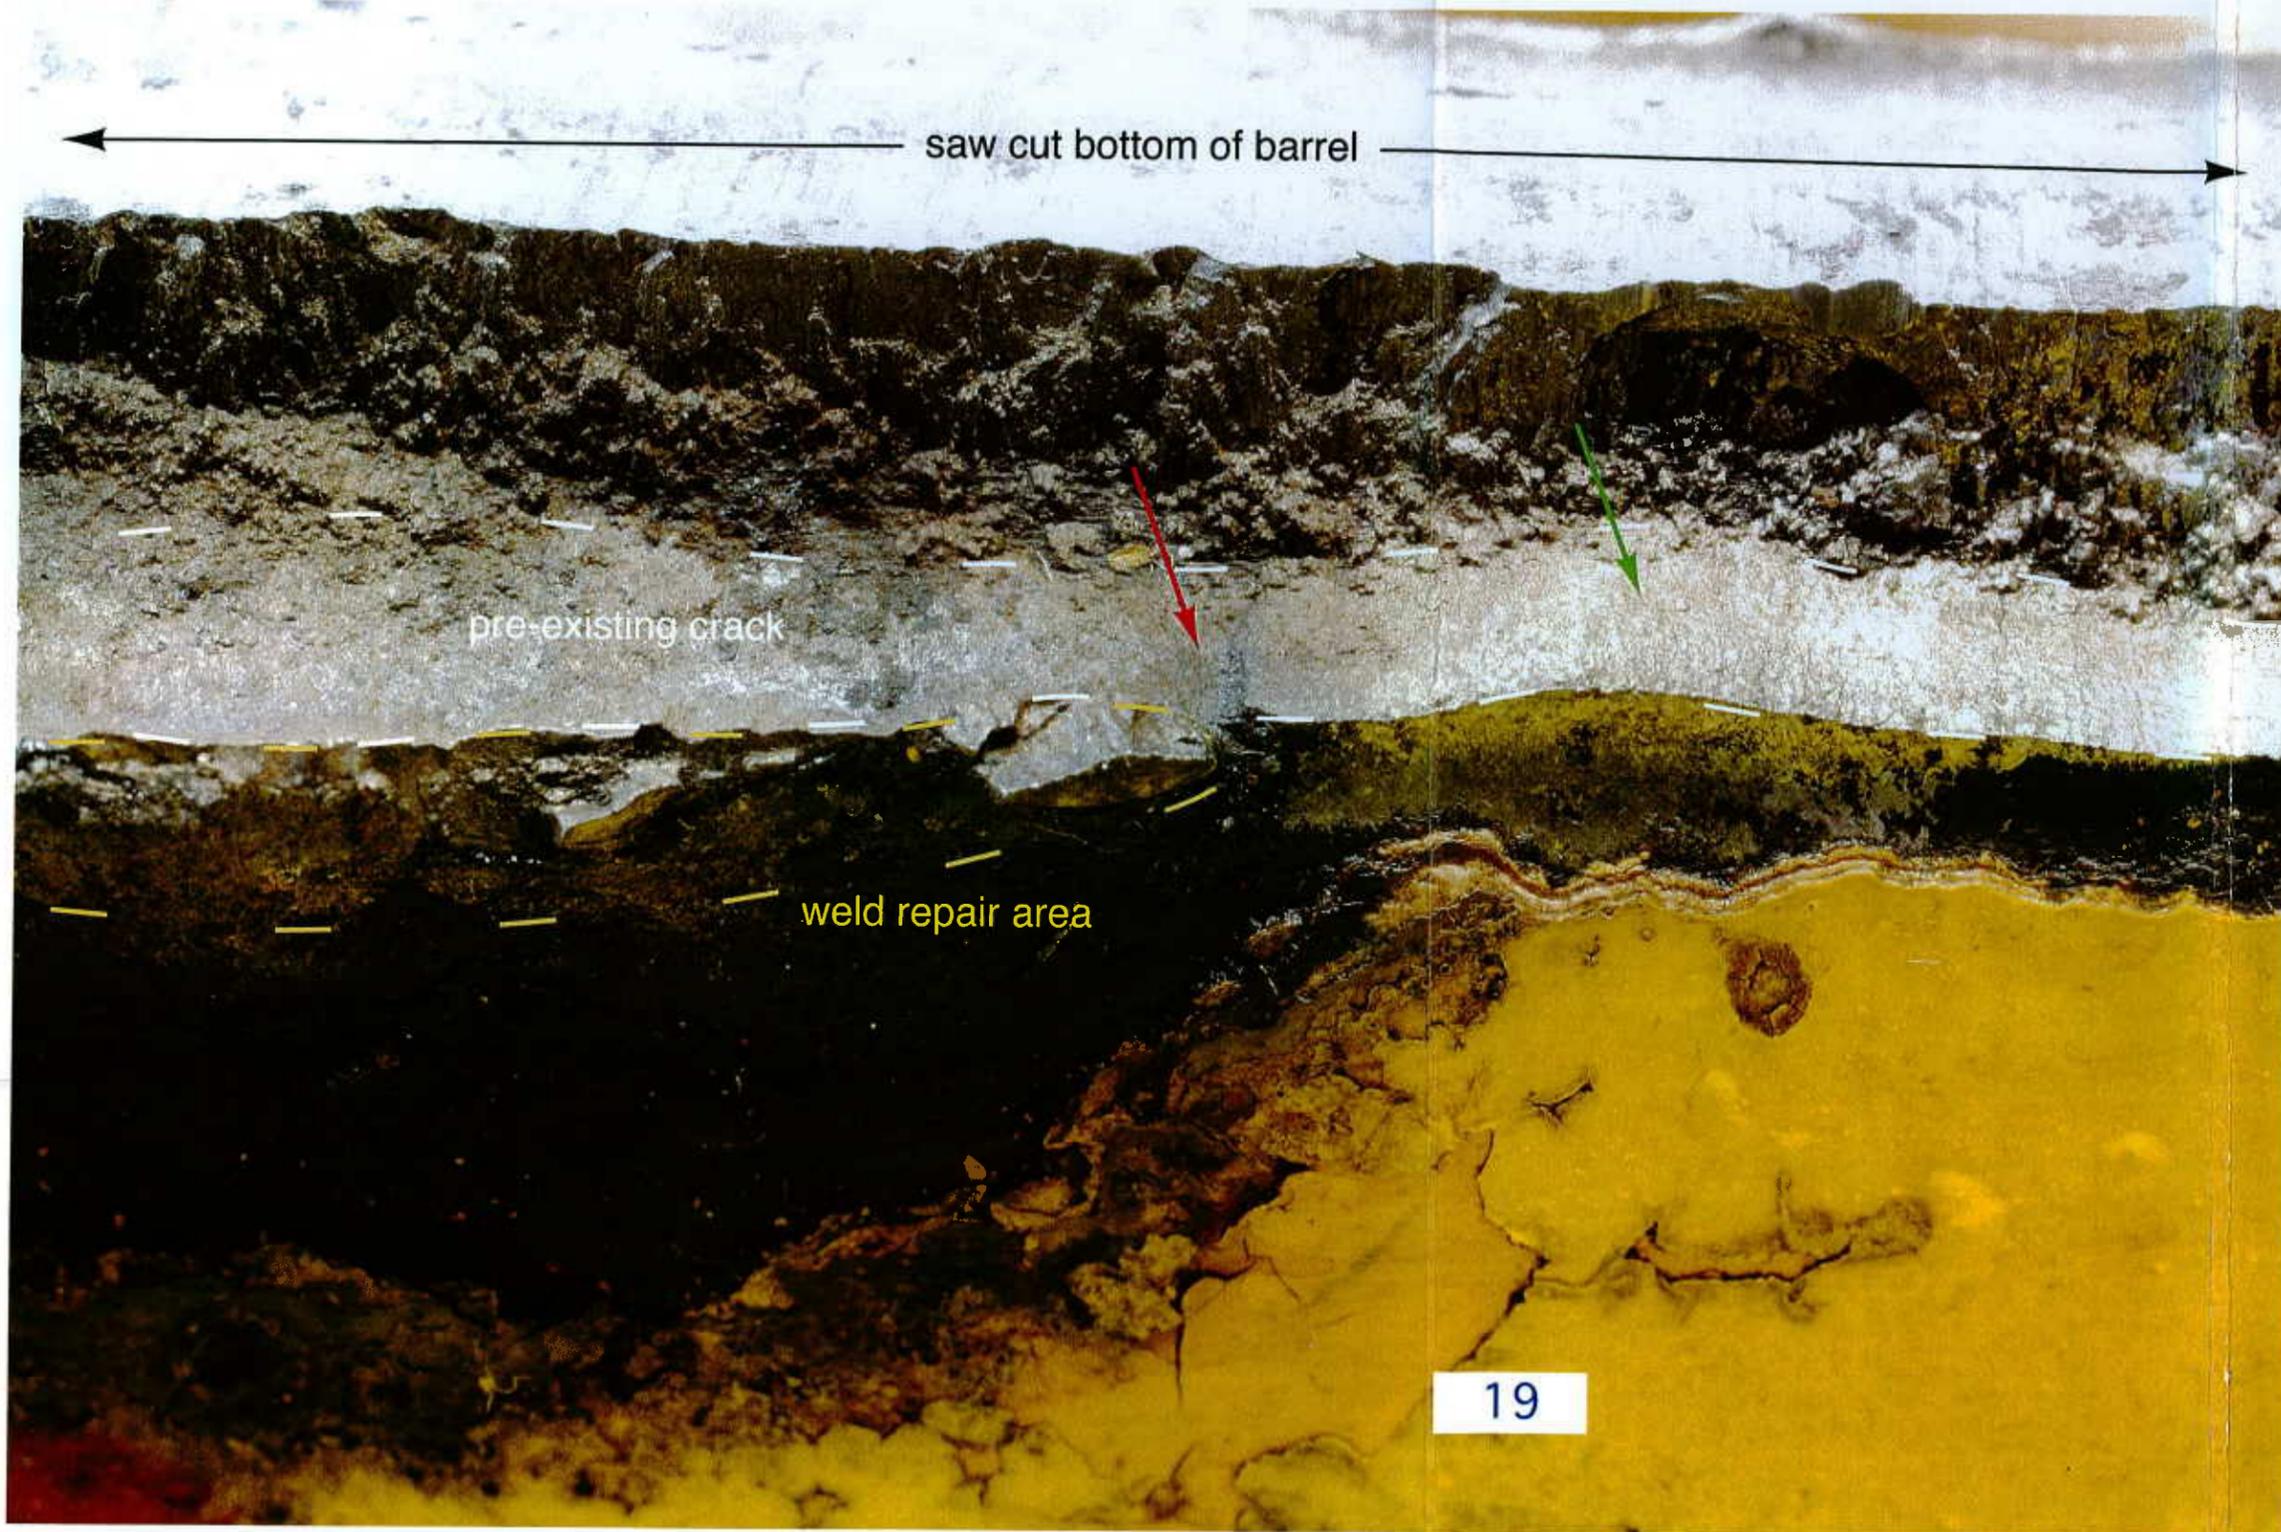
C5

Oblique view of the flange fracture near 19. This view depicts the end of the weld repair (yellow dashed lines), as identified by the heat tinting on the fracture surface (red arrow - brown coloured high temperature oxide). Note the cleaner looking fracture to the right of the oxide coated surface (green arrow). This fracture to the right is clearly part of the same crack which existed prior to the weld repair (white dashed lines).

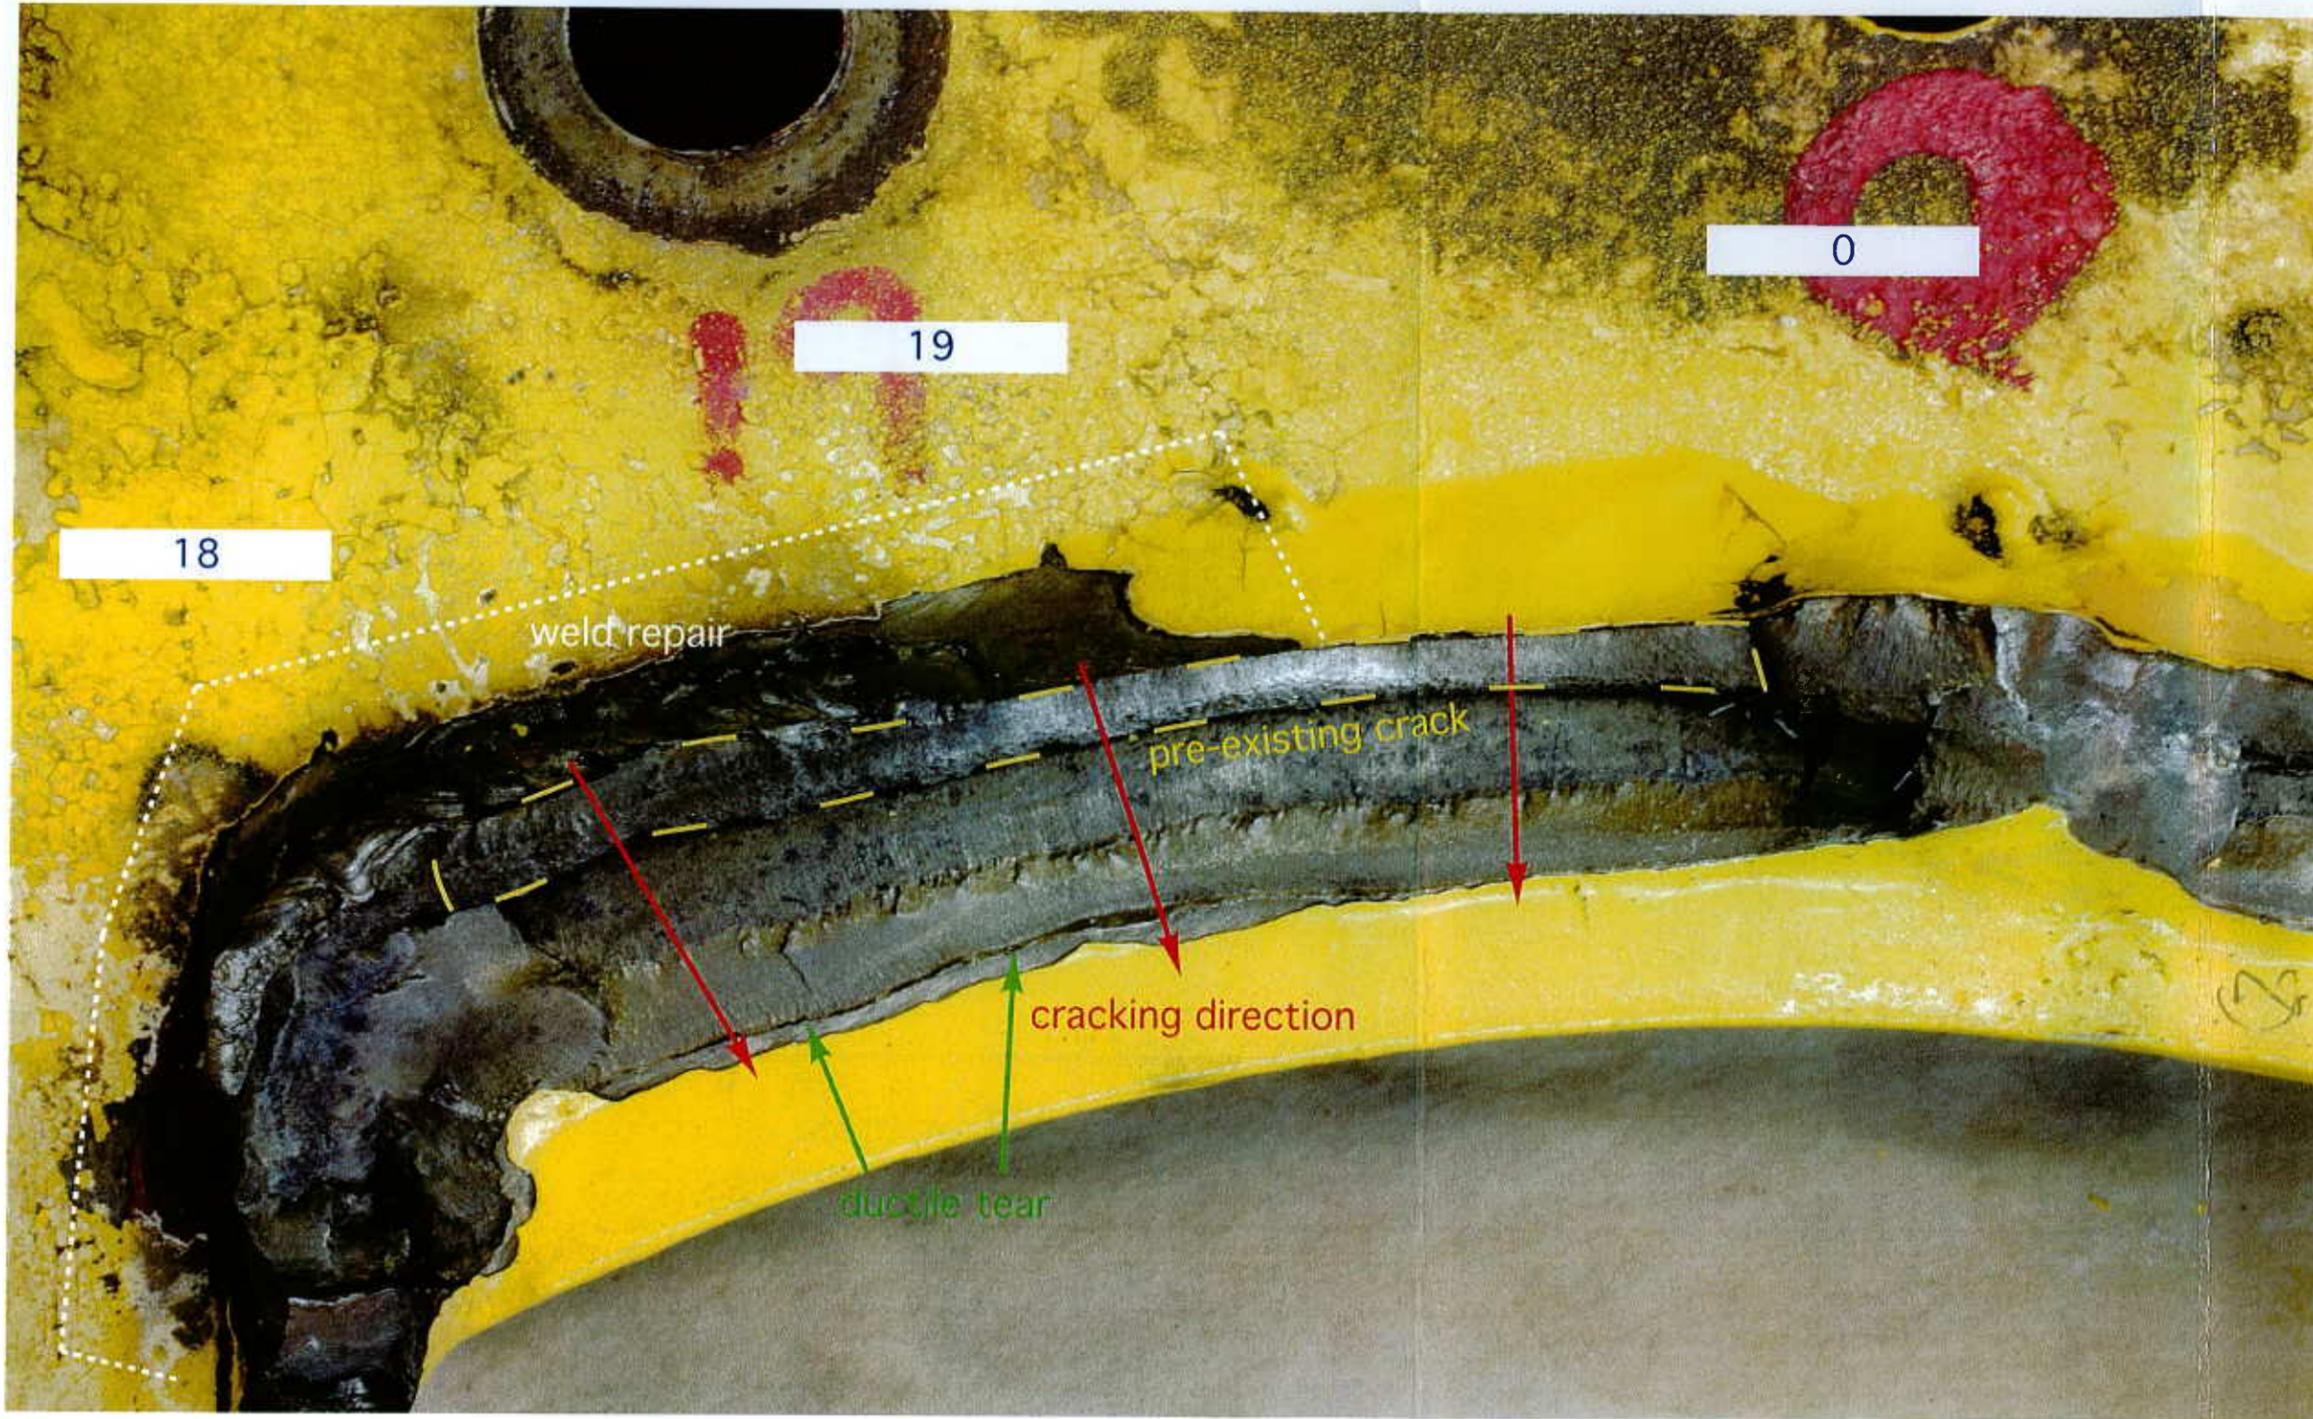
4.5.6 Photograph C6 is a view depicting the mating flange fracture in locations 0, 18 and 19. This view also clearly depicts a fatigue crack that existed prior to the weld repair crack and extended beyond the weld repair. It is also clear in this view that the weld repair placed a covering layer over this crack and that this pre-existing fatigue crack in the manufacturer's weld was not gouged clean and replaced with weld metal.

Close-up view of the flange fracture in zones 18, 19, and 0. The overall cracking direction is indicated by the red arrows. This is the mating fracture surface to Photograph C3. Once again, at the edge of the weld repair (white dashed line), location 19, a pre-existing crack is visible which was clearly not repaired by the weld (yellow dashed lines).
