CONFIDENTIAL ANALYSIS FOR THE MINISTER OF MUNICIPAL AFFAIRS

**NORTH AMERICAN MIDWAY ENTERTAINMENT
SCORPION RIDE ENGINEERING ASSESSMENT
DATE OF LOSS: JULY 16, 2010**

ANDERSON ASSOCIATES CONSULTING ENGINEERS INC.
APEGGA Permit Number P 2205

November 26, 2010

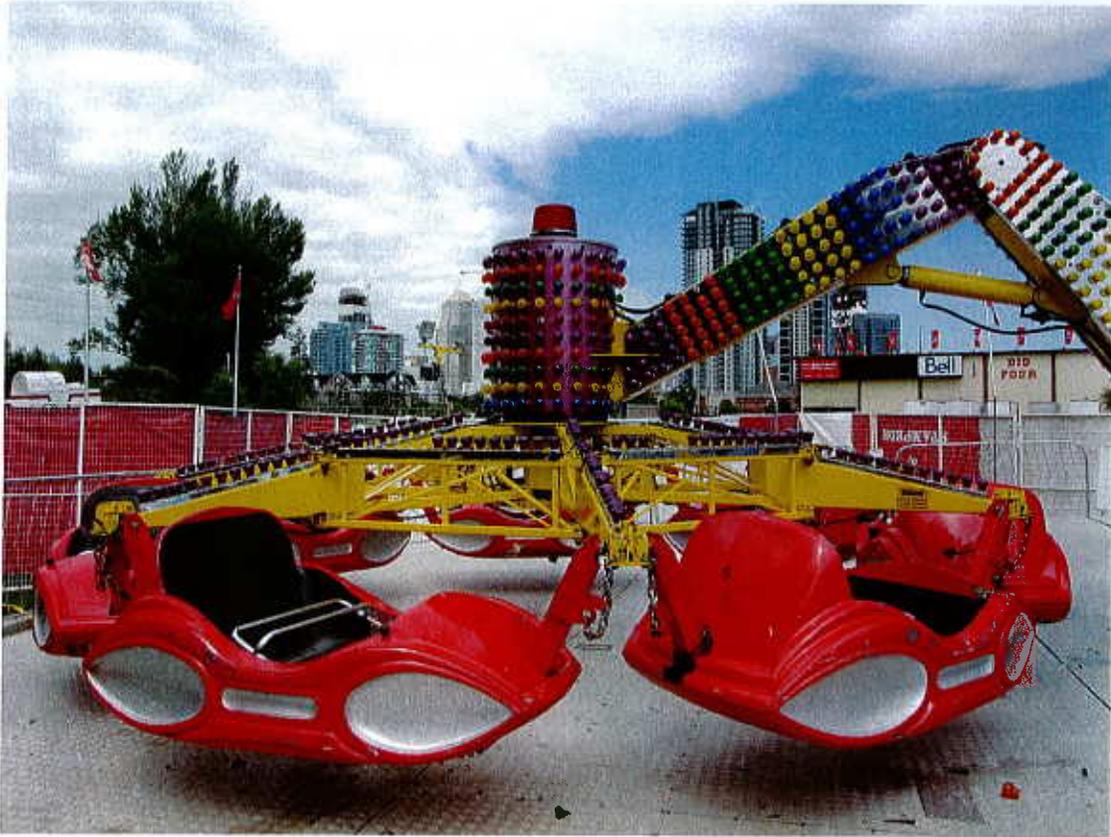
A5

A view of the red spinner sweep assembly from deck level.

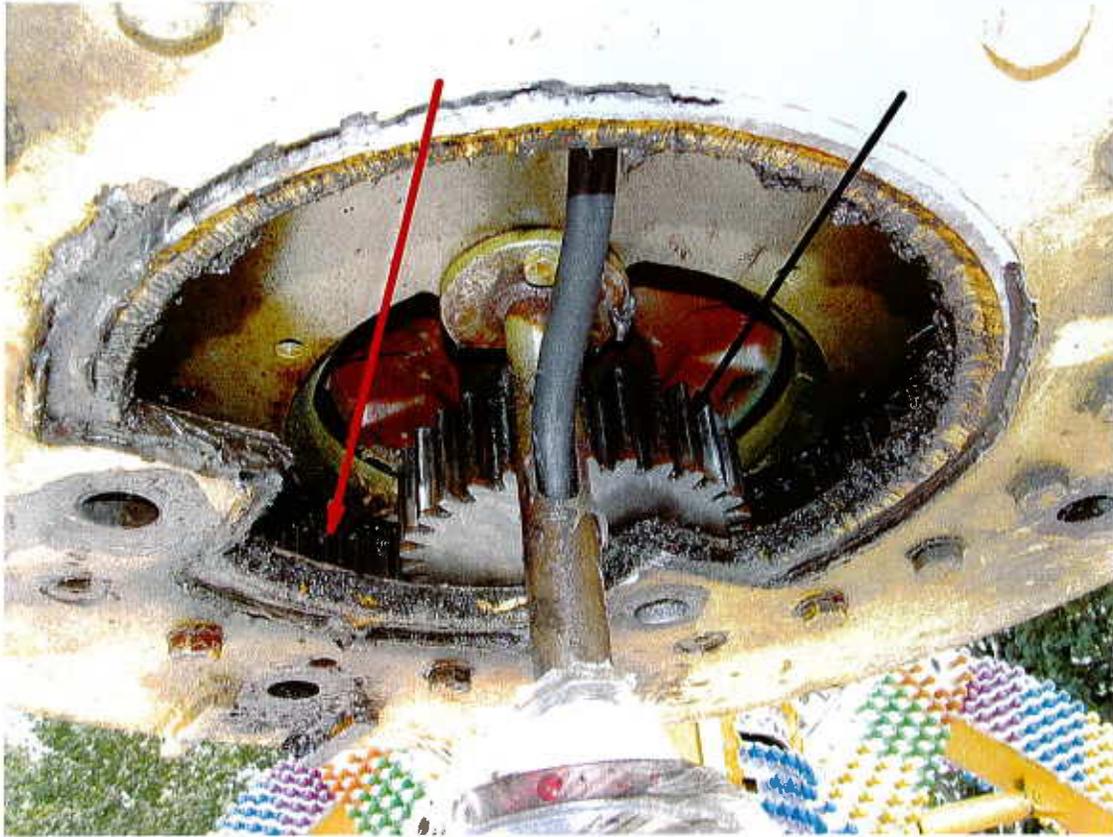
A9

A view showing the driving pinion gear (black arrow) meshed with its respective driven gear (red arrow).

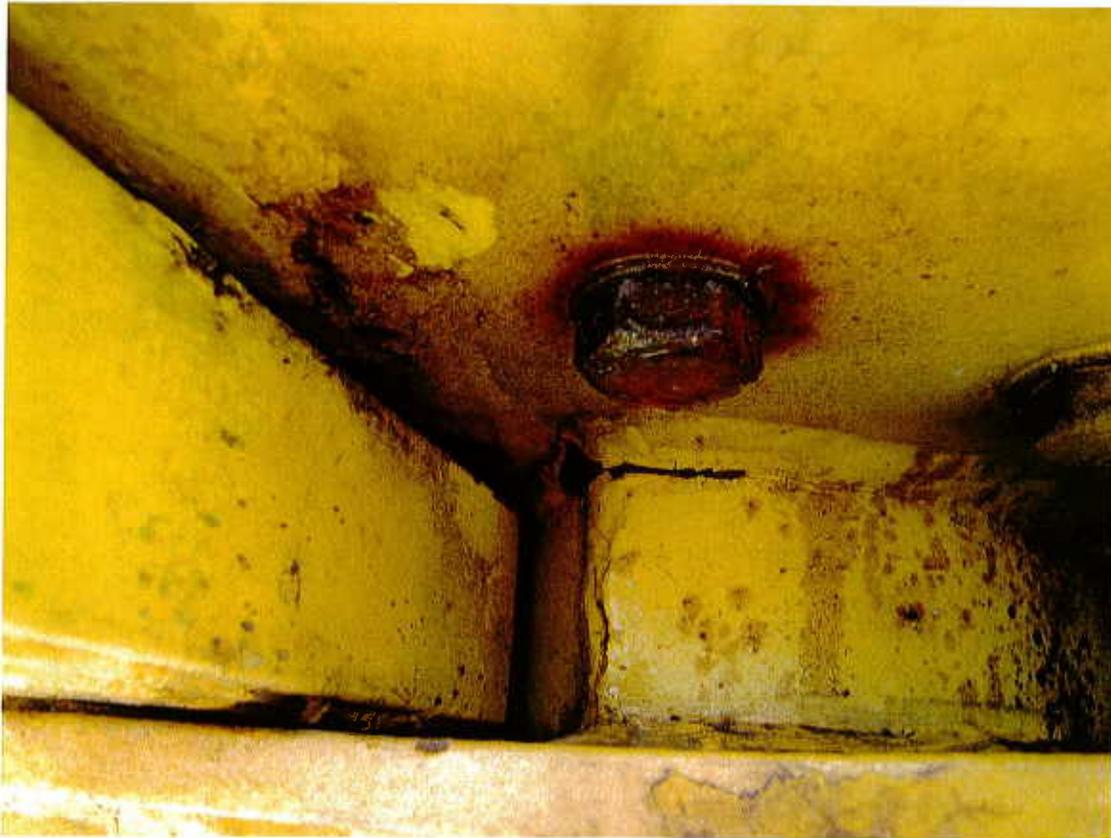
A15

A view of the barrel to top flange weld on the blue spinner sweep assembly at a location just right of the adjacent sweep arm identified in photo A13.

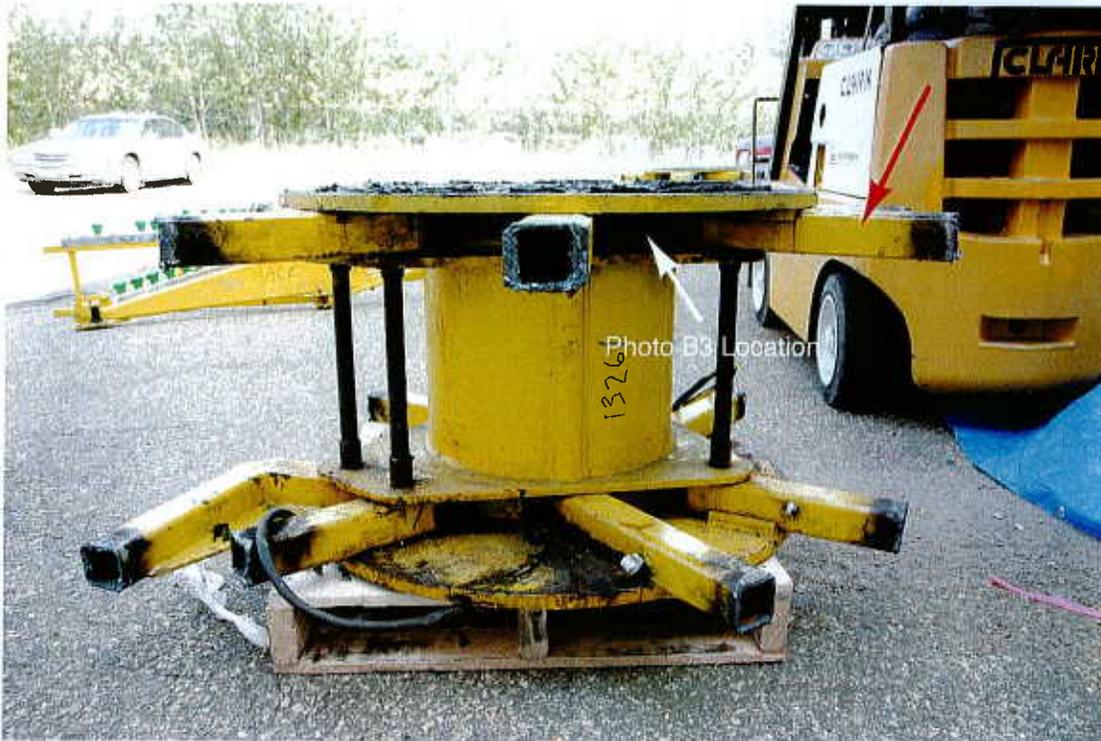
B1

View showing the blue spinner hub "as received".

Note the spinner sweep arms have been torch cut for shipping. The red arrow identifies the fixed spinner sweep arm.

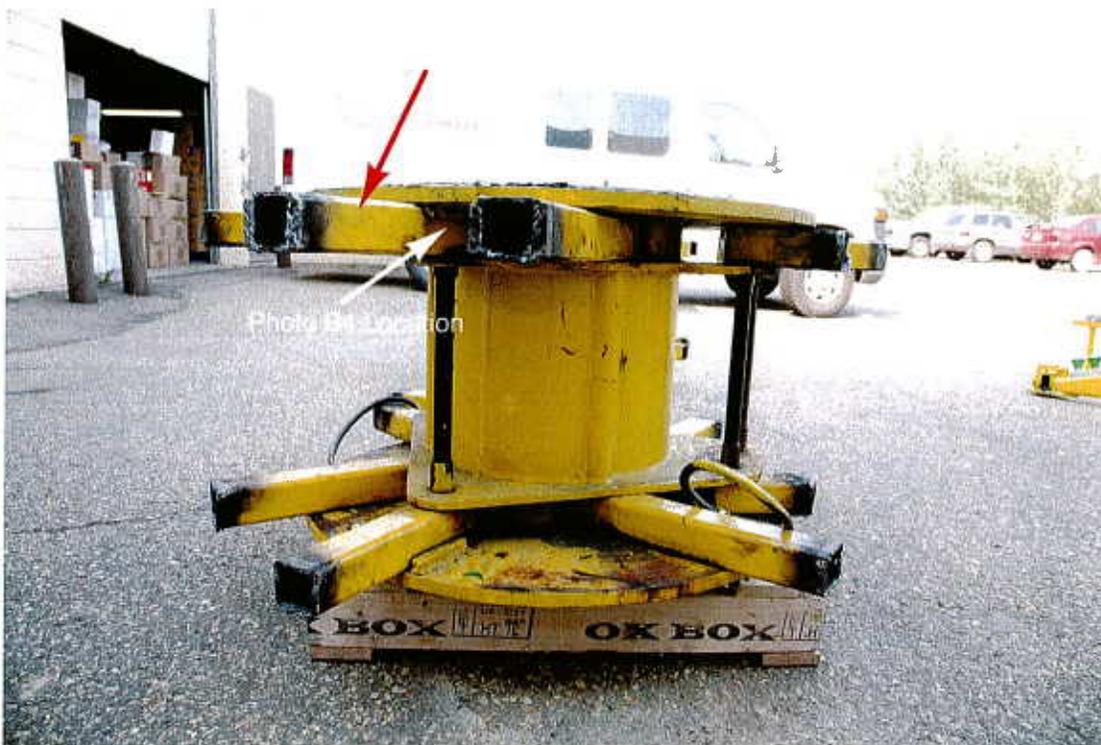
B2

Alternate view showing the blue spinner hub "as received".

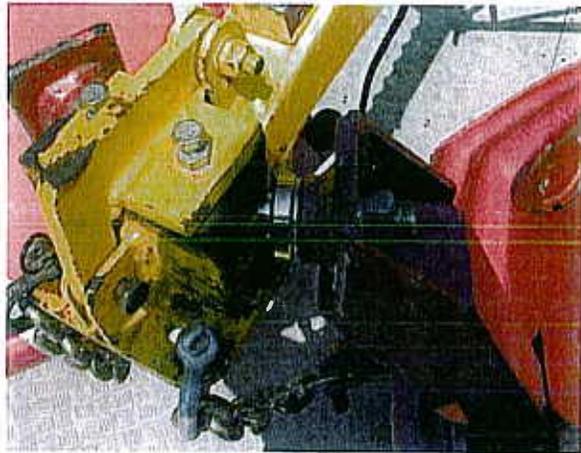
This ride has been extensively refurbished, with many components replaced. The suspension bolts and safety back-up chains are all new (see photo, right) and the electrical panel has been completely overhauled
